Blumberg No. 5137
RSC JC
Warrers Bayou
Photos 1/29/13

Warner's Bayou Boat Ramp

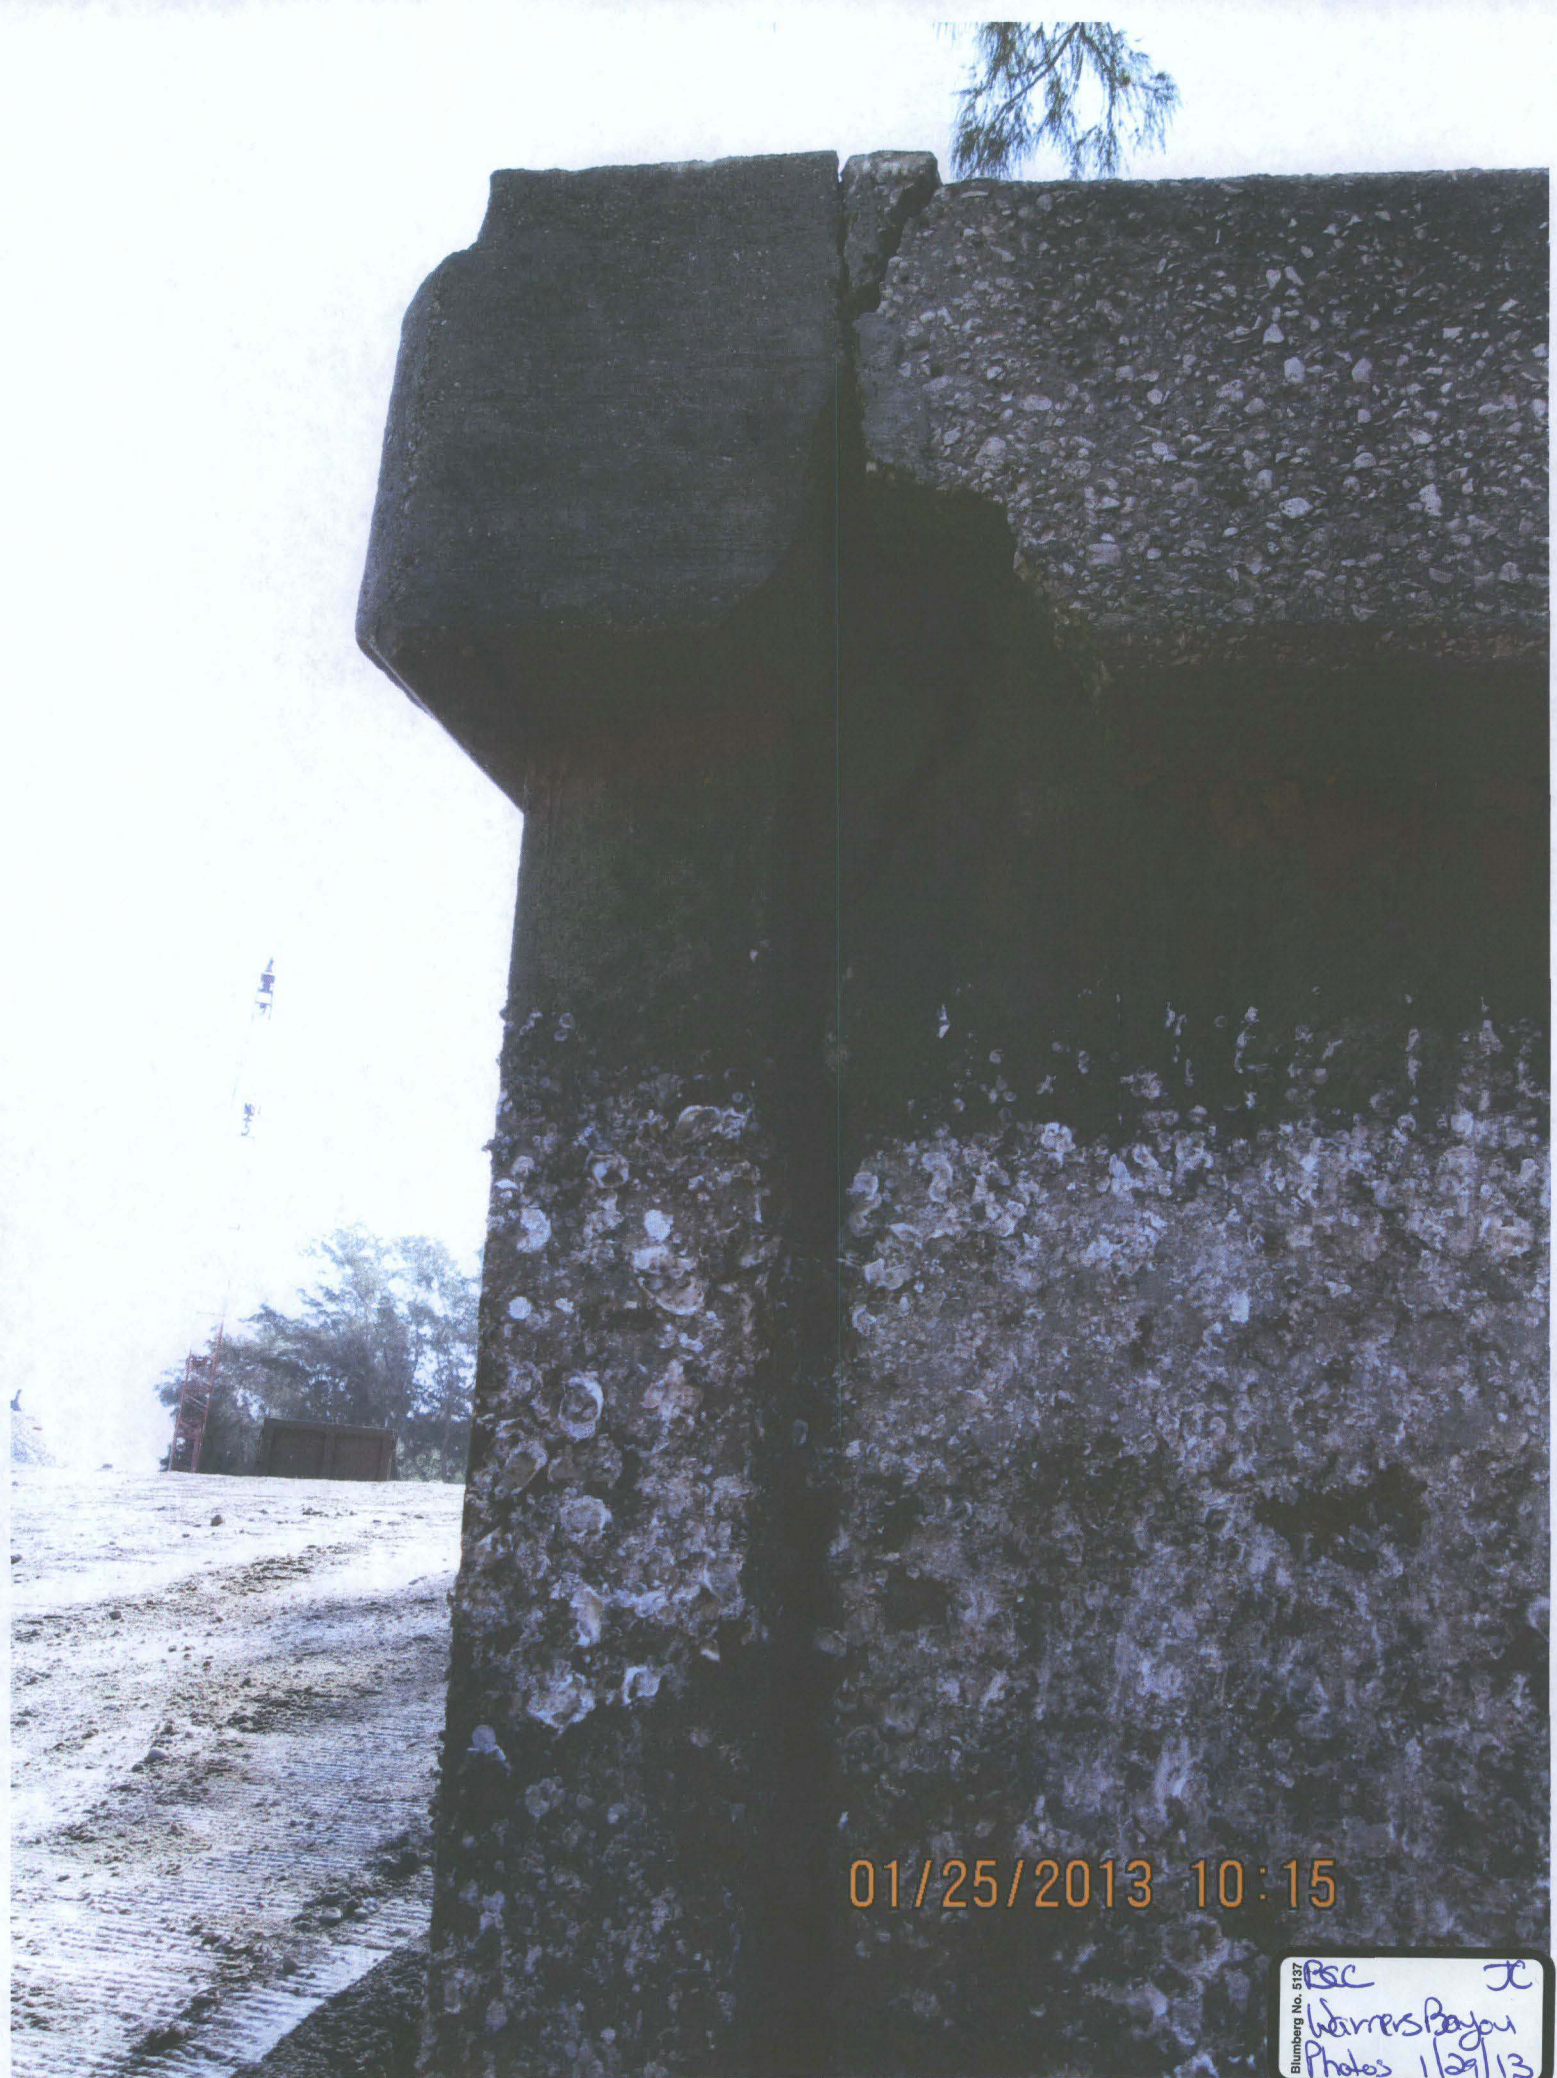
Significant separation of columns at base of ramp, uncovered during dewatering, indicating imminent failure.

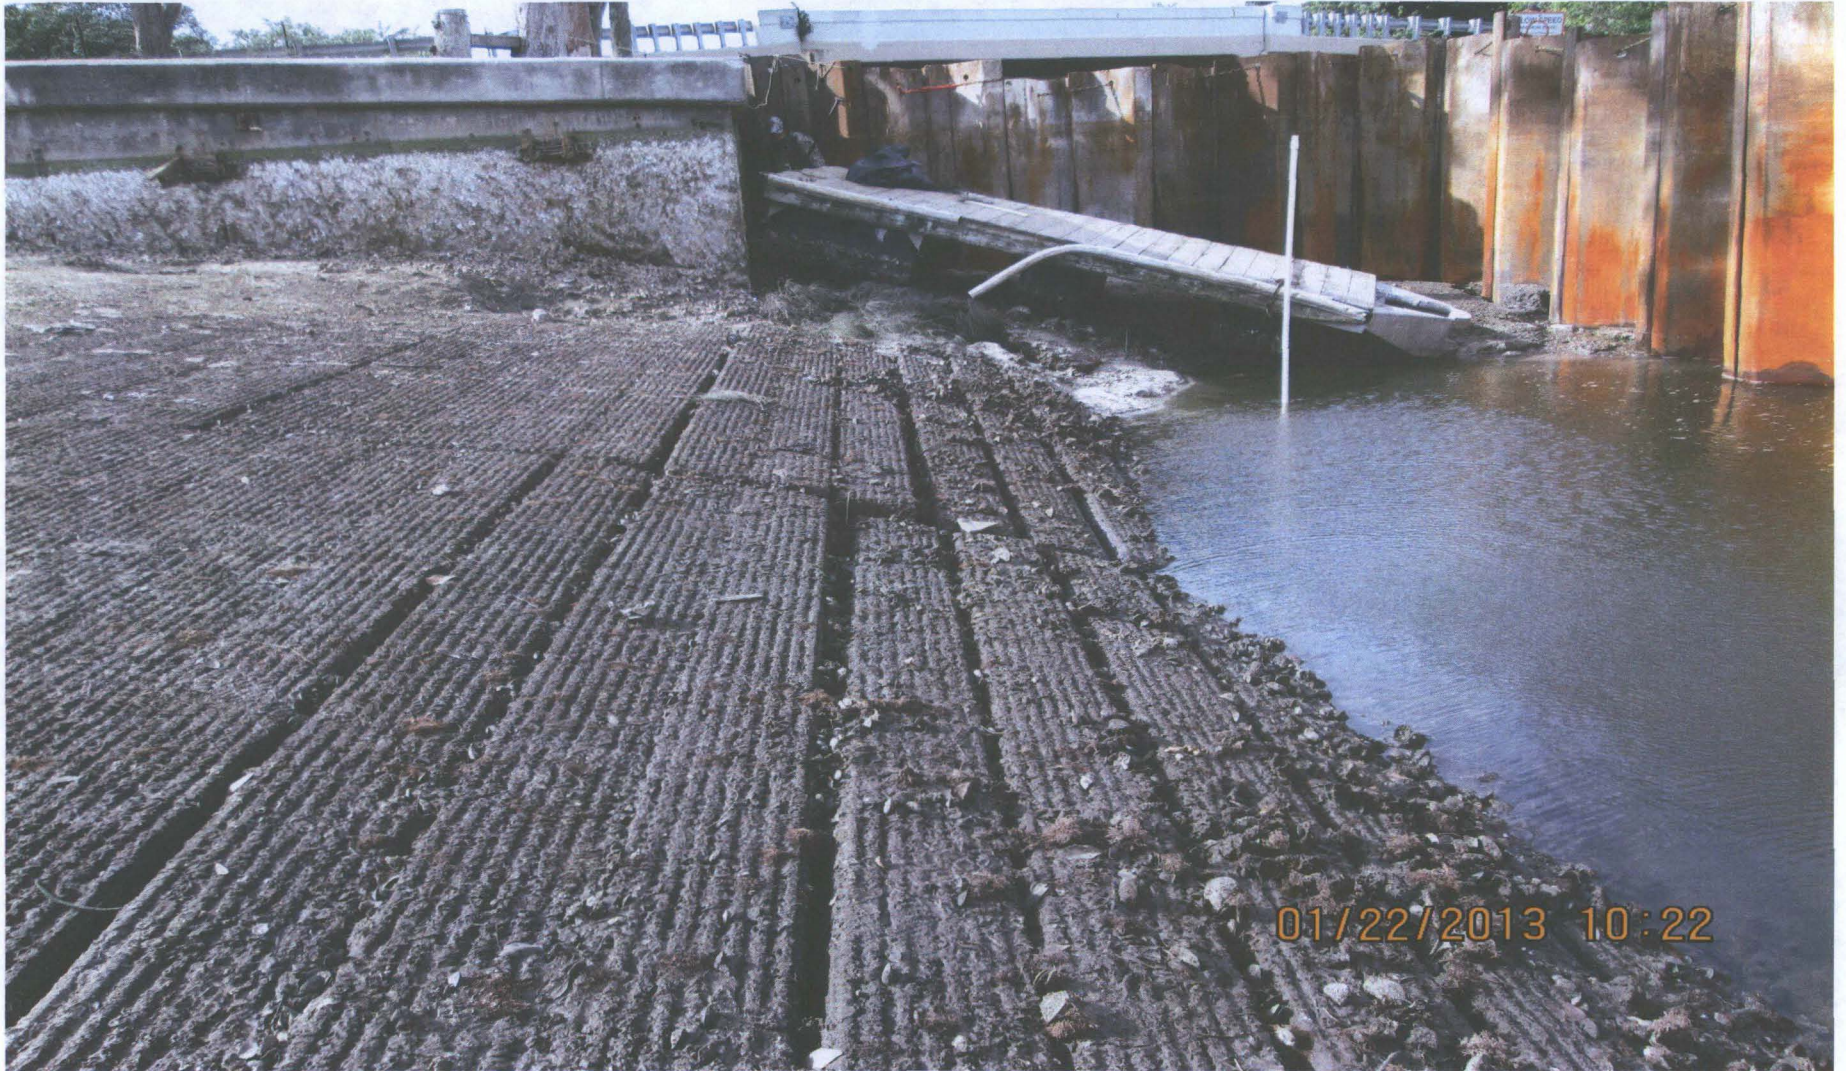
Seawall panel separation, observed after dewatering of the south ramp/dock area. The panels have not moved significantly but auxiliary tie-backs should be installed to preserve their integrity. It is the opinion of the seawall contractor that two large Australian Pines in close proximity to the separation pose a threat to the structural integrity of the wall and must be removed; the trees must also be removed in order to install the tie-backs.
