MANATEE COUNTY & THE TOWN OF LONGBOAT KEY

COASTAL PLANNING & ENGINEERING, INC.

OCTOBER 2011

Executive Summary

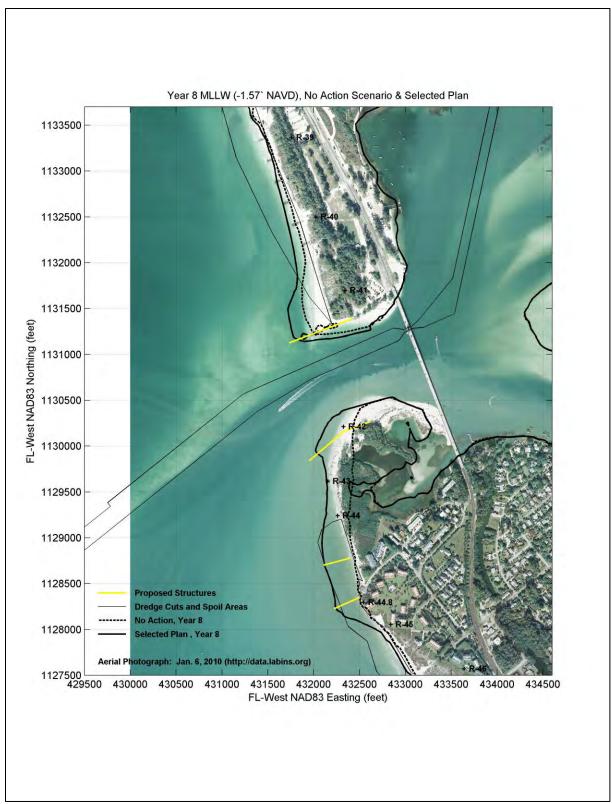
FIGURE E-1: Recommended Inlet Management Plan for Longboat Pass.

To address the erosion problems at Longboat Pass, an inlet management plan has been formulated using the information presented in this document and intergovernmental coordination between local stakeholders. The plan combines the following elements (see Figure E-1):

- An extension of the existing terminal groin on the south end of Anna Maria Island.
- The construction of a terminal groin on the north end of Longboat Key, plus two permeable adjustable groins near the 360 North Condominium and the public beach access at the end of North Shore Road.
- Dredging of the 1977 Authorized Channel with approximately 38,700 c.y. of advance maintenance on the north side of Cut 1 and placement of the spoil material on the southern mile of Anna Maria Island (R-35+790' to Longboat Pass) and the north end of Longboat Key between Greer Island and Gulfside Road on an as needed basis (R-44+48' to R-46A and R-48+722' to R-51).
- Dredging of Gulf Intracoastal Waterway Cut M5.

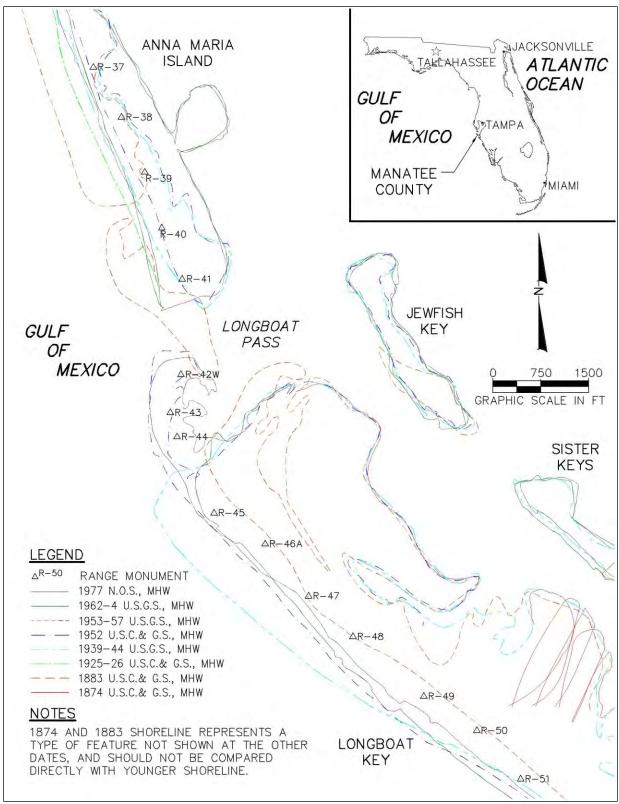
FIGURE 1-3: Historic shoreline change showing shoreline positions along the southern end of Anna Maria Island and the northern end of Longboat Key, for selected time intervals from 1874 to 1977.

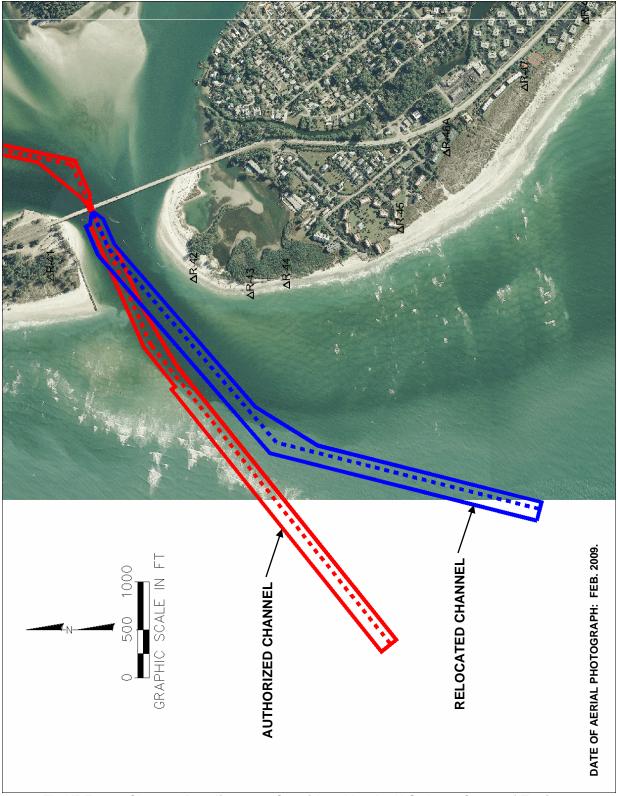
FIGURE 1-4: Channel Re-Alignment Considered by the U.S. Army Corps of Engineers (Mora, 2010).

• Re-align Cuts 1 and 2 of the Federal navigation channel "to conform more closely to the natural tidal channel alignment." Although not specified in the 2008 study, the channel proposed by the U.S. Army Corps of Engineers (USACE) for future dredging in Longboat Pass appears in Figure 1-4. It should be noted, however, that during the next Federal dredging operation, the USACE is only planning to dredge Cut 3, the landward half of Cut 2, and the Gulf Intracoastal Waterway; dredging seaward of the Longboat Pass bridge will not take place. FDEP granted a Notice of Intent to Issue Permit and Variance for the upcoming Federal dredging operation on September 29, 2011.

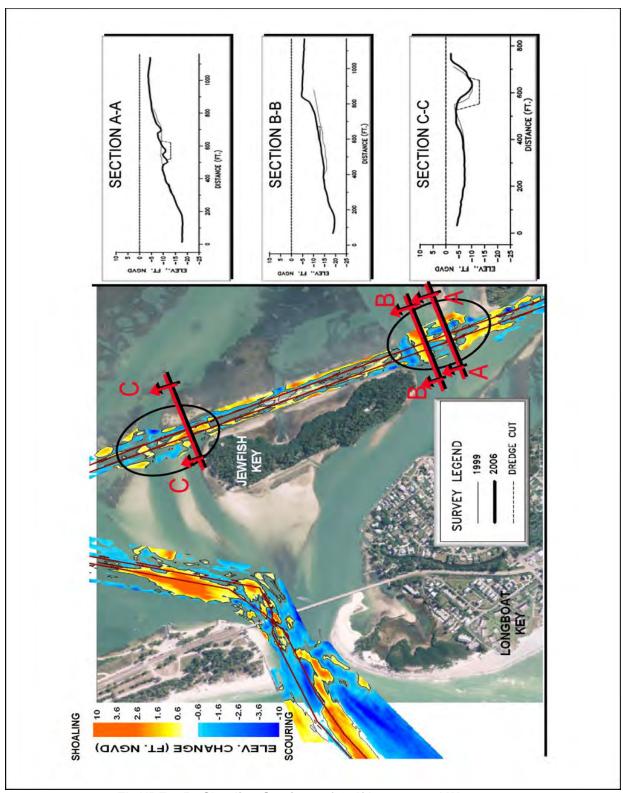
FIGURE 1-5: Shoaling Sections of Gulf Intracoastal Waterway (Humiston & Moore, 2008, p. 67).

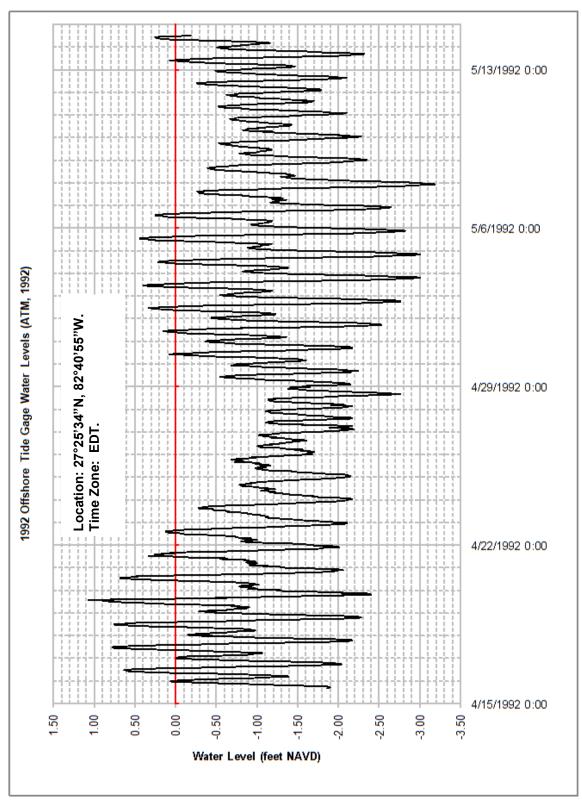
FIGURE 2-1: Typical Observed Gulf Tides (ATM, 1992).

Tides at the project location are mixed tides. Typical observed tides near the Gulf shoreline (ATM, 1992, see Figure 2-1) appear in Figure 2-1. During the majority of the 14-day springneap cycle, there are two (2) high and two (2) low tides each day, with different high tide and low tide elevations. However, during a small portion of the 14-day cycle, there is only one high tide and one low tide each day. Published tidal datums at the locations in Figure 2-2 appear in Table 2-2. Differences between the published tidal datums (LABINS, 2003) and the observations in Figure 2-1 are probably due to local effects such as wind stress. Although the mean tidal range in the Gulf, based on the established tidal datums is 1.4 feet, the tide range during spring tides can exceed 3 feet, as shown in Figure 2-1. Within the bay, the tide range ranges from 1.3 to 1.5 feet.

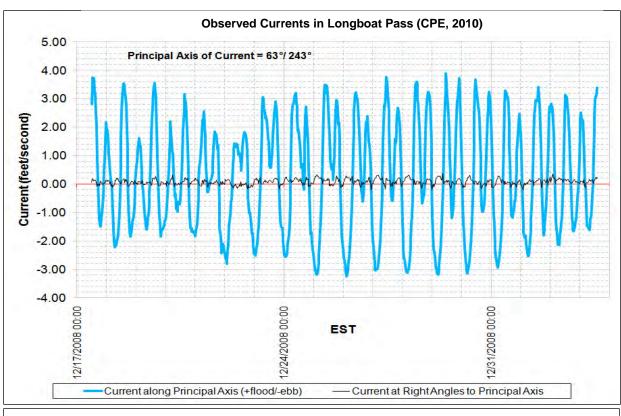
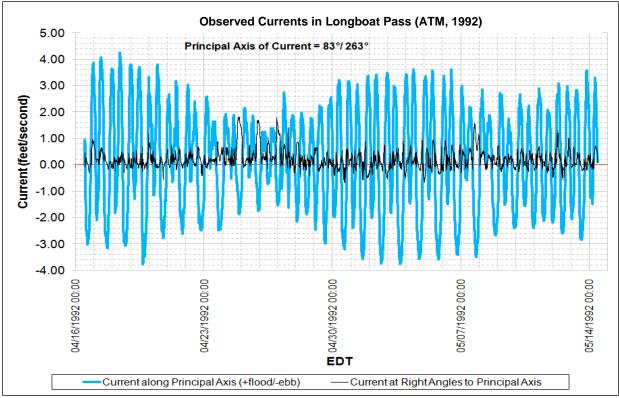
FIGURE 2-11: Typical Observed Currents in Longboat Pass.

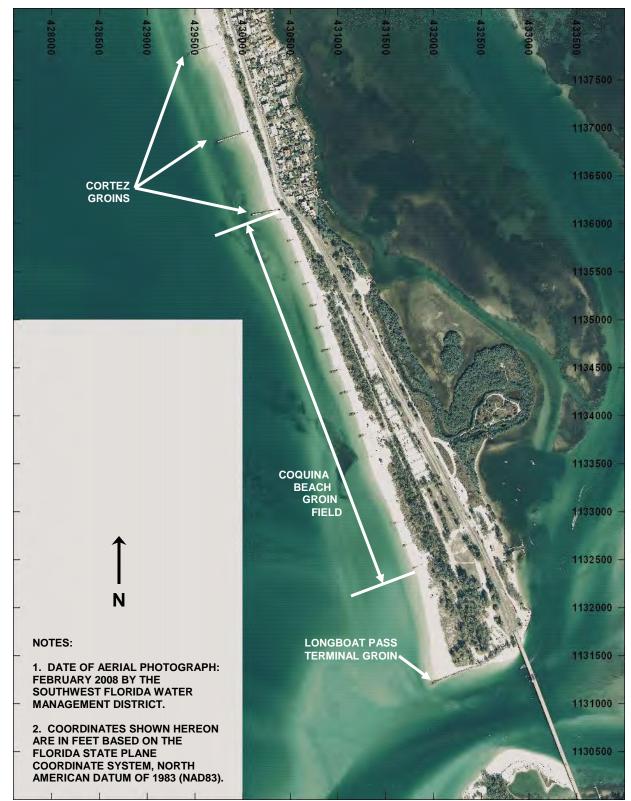
FIGURE 2-12: Structures on Anna Maria Island near Longboat Pass.

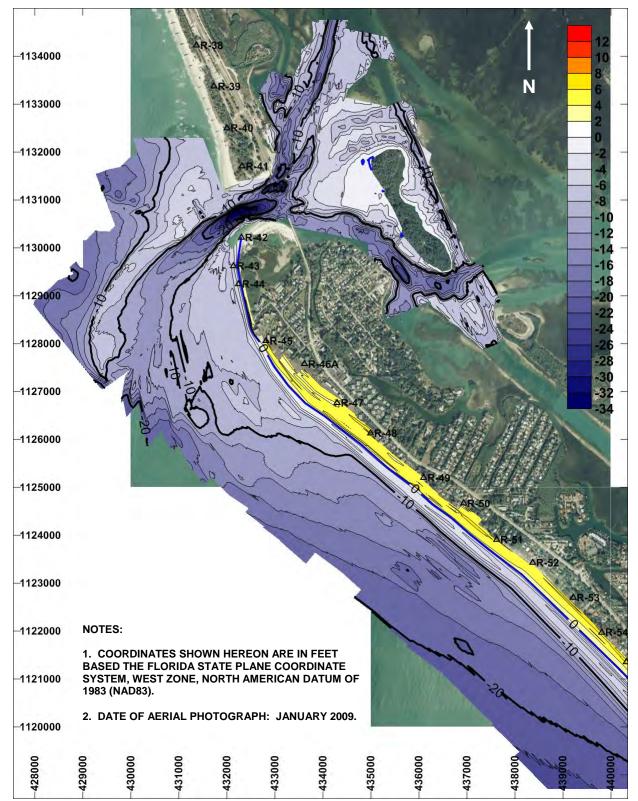
FIGURE 2-15: Longboat Pass March-October 2009 Bathymetry (feet NAVD).

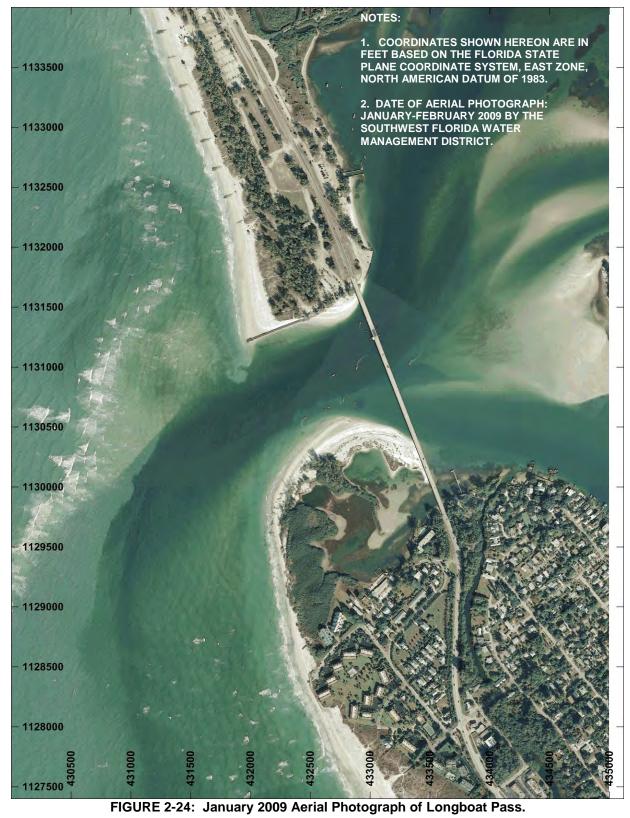
FIGURE 2-24: January 2009 Aerial Photograph of Longboat Pass.

Between 1940 and 1951, sand from the eroding beaches to the south contributed to the development of a 2,000 foot long spit that extended into Longboat Pass (Figure 2-20). In the early 1960's the spit was breached (Figure 2-21). At that time, the reach of shoreline between R-42 and R-44 was bordered by two tidal channels and became known as Beer Can Island. The second channel ran parallel to North Shore Road (R-44.5). In 1966, the Town of Longboat Key dredged a boat channel from the southern end of the bridge into the main channel. The dredged channel diverted tidal flow and caused southern channel to close (Figure 2-22). The spit curved south at approximately R-42 and continued to grow south until the early 1980's (Figure 2-23). Since then, a second spit has developed and curved south. Currently, sand moves to the island's terminus and is either transported into Longboat Pass or wraps around the spit into the bay at the bridge (Figure 2-24). The active spit is positioned east of the historic spit (CPE, 2006).

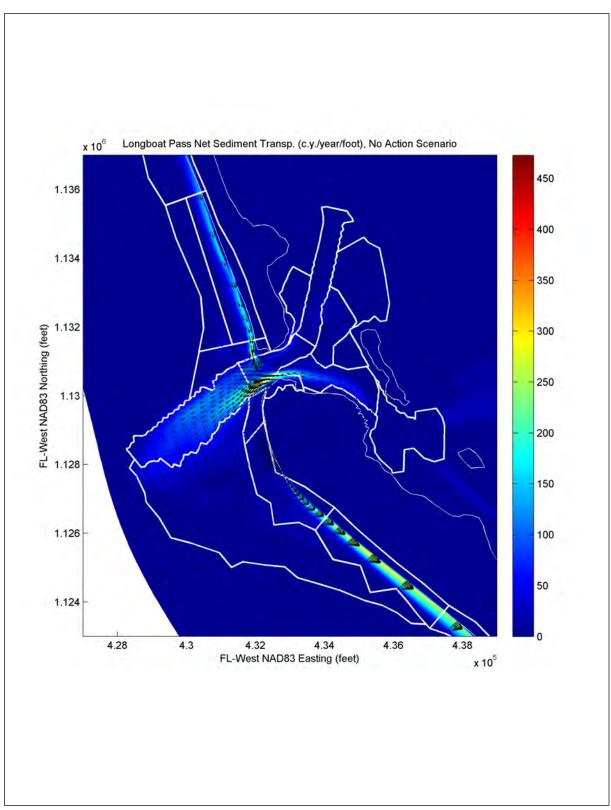
FIGURE 2-41: Delft3D Sediment Transport Patterns near Longboat Pass, Longboat Key North End Breakwaters Project (CPE, 2010), No Action Alternative.

Volume changes on the north end of Longboat Key are dominated by the rapid loss of material from Reach 1S (R-44 to R-47), which exhibits some of the highest erosion rates on the island. The Delft3D results in Figure 2-41 support the assumption that Reach 1S contains a nodal point. When the observed volume change of 6,000 c.y./year is combined with 25,000 c.y./year of beach fill, the effective erosion rate is 31,000 c.y./year. Of this amount, approximately 15,000 c.y./year are transported into Reach 2 (R-47 to R-51), with 10,000 c.y./year moving into Reach 1N (R-42 to R-44). The remaining 6,000 c.y./year moves into the Southern Ebb Shoal offshore.

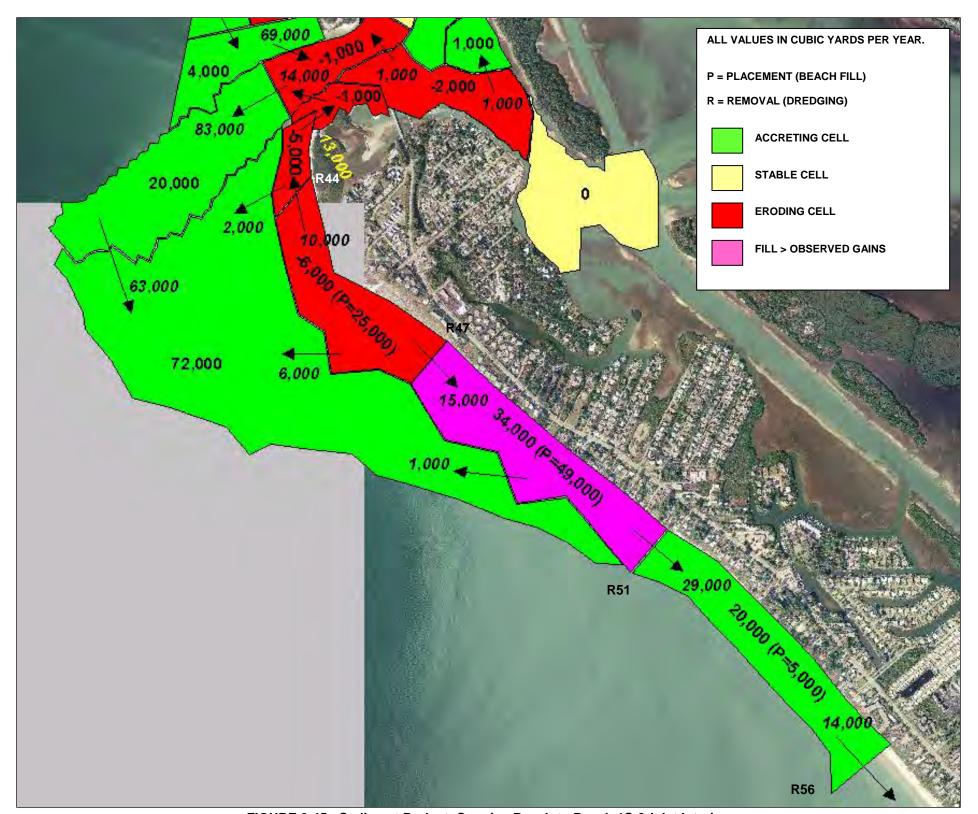
FIGURE 2-45: Sediment Budget, Coquina Beach to Reach 1S & Inlet Interior.

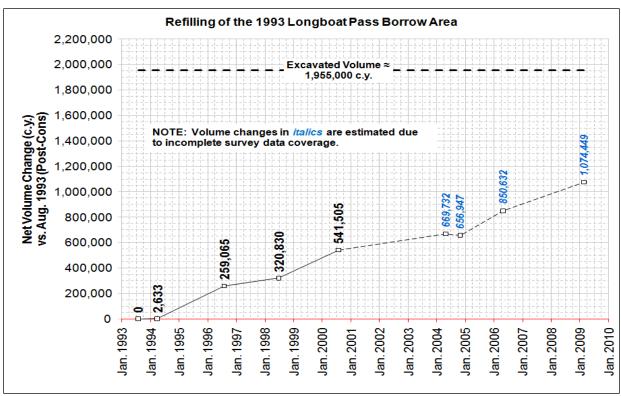
FIGURE 2-49: Refilling of the 1993 Longboat Pass Borrow Area.

The refilling of the 1993 Longboat Pass borrow area appears to be contributing to this effect. Bathymetric changes in the 1993 Longboat Pass borrow area appear in Appendix C. Based on the December 1992 and August 1993 surveys, approximately 1,955,000 c.y. were removed from the borrow area during the construction of the Longboat Key Beach Restoration Project. Between August 1993 and March 2009, the net volume change within the borrow area was 1,074,000 c.y. (see Figure 2-49), equal to a rate of 69,000 c.y./year. It should be noted that the refilling has been relatively constant since 1993 and has recovered about 55% thus far. Given present rates, the borrow area is expected to refill by 2021 or 2022. As noted in the previous section, the ebb shoal is currently gaining 96,000 c.y./year. The refilling rate of 69,000 c.y./year represents 72% of this gain.

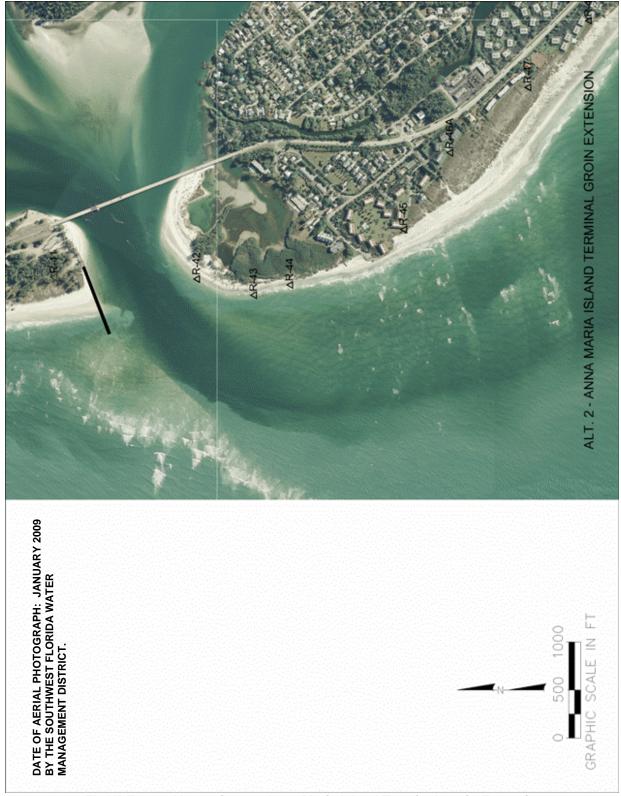
FIGURE 4-1: Alternative 2 – Anna Maria Island Terminal Groin Extension.

- 1. No Action.
- 2. Anna Maria Island Terminal Groin Extension (Figure 4-1).
- 3. Longboat Key terminal groin options:
 - a. Single groin (Figure 4-2).
 - b. Twin terminal groins (Figure 4-3).
- 4. Longboat Key Terminal Groin Plus Breakwater (Figure 4-4).
- 5. Longboat Key Terminal Groin Plus Two Permeable Adjustable Groins (Figure 4-5).
- 6. Inlet channel dredging options:
 - a. Authorized Channel (Figure 4-6).
 - b. Relocated Channel proposed by U.S. Army Corps of Engineers (Figure 4-7).
 - c. Relocated Channel following the recommendation of Humiston & Moore (Figure 4-8)
 - d. Authorized Channel with Advance Maintenance (Figure 4-9).
- 7. Dredging of Gulf Intracoastal Waterway Cut M5 (near Jewfish Key) (Figure 4-10).
- 8. Combinations of the above alternatives into a comprehensive plan.

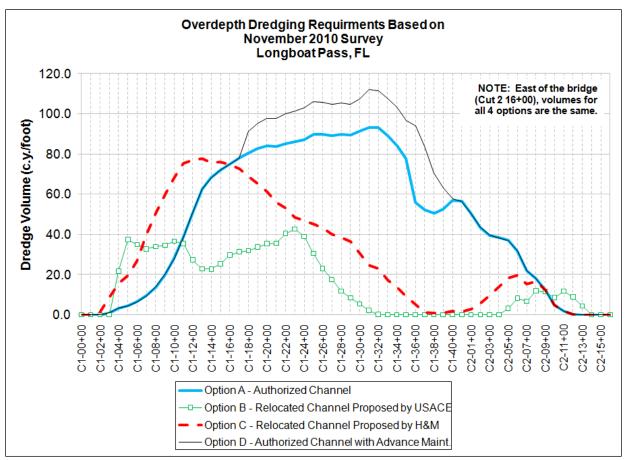
FIGURE 4-17: Distribution of Initial (Year 0) Inlet Channel Dredging along the Channel for Each Alternative.

Initial dredging volumes appear in Figure 4-17 and Table 4-1. The primary differences between the dredging options are the configurations of the channel west of the Longboat Pass bridge (Cut 1 00+00 to Cut 2 16+00). East of the bridge, the dredging options are identical. For each simulation the dredge spoil was evenly split between the two adjacent islands.

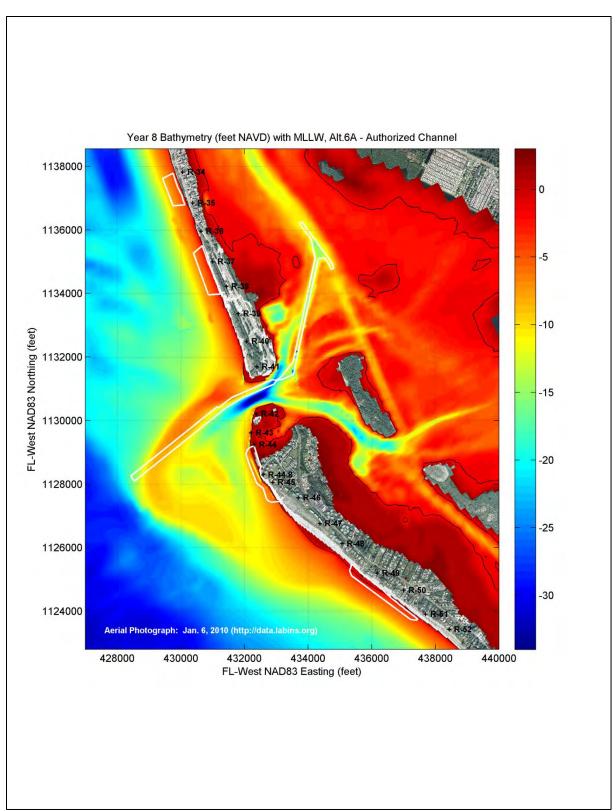
FIGURE 4-18: Predicted bathymetry 8 years after the dredging of the Authorized Channel (Alternative 6A). White polygons along the beach show the dredge spoil placement areas as simulated.

On Anna Maria Island, the dredging of the Authorized Channel may result in additional erosion along Coquina Beach between R39 and Longboat Pass (Appendix A). The impact is estimated to be within the 10-12 c.y./year/foot range at R41 tapering to zero near R39. The futher development of the swash channel near the existing terminal groin is expected.

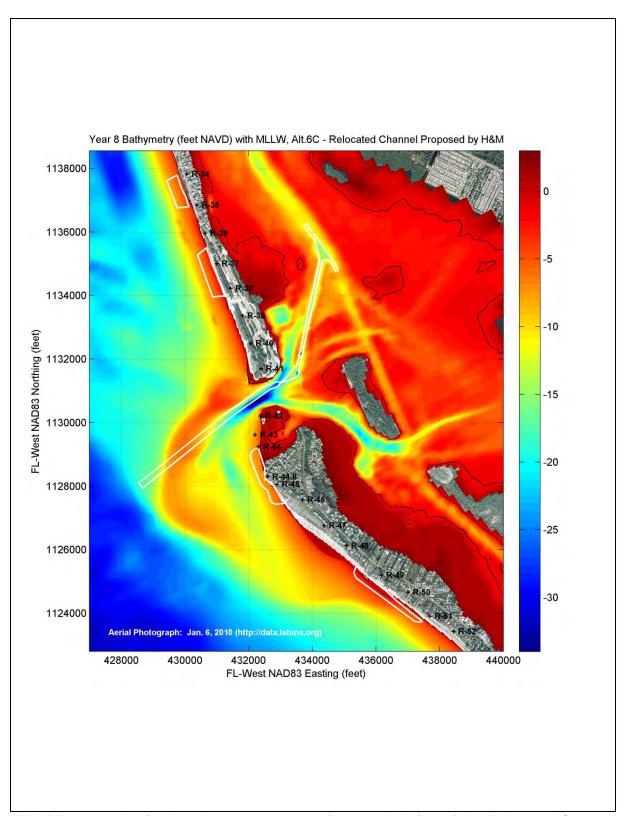
FIGURE 4-20: Predicted bathymetry 8 years after the dredging of the Relocated Channel Following the Recommendation of Humiston & Moore (2008) (Alternative 6C). White polygons along the beach show the dredge spoil placement areas as simulated.

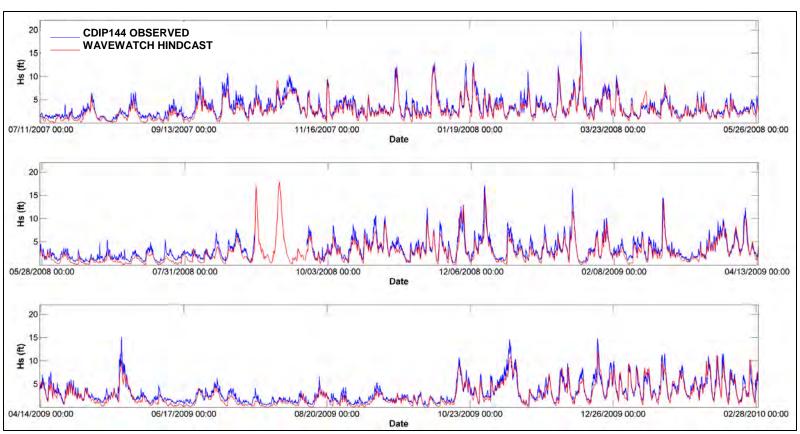
FIGURE 2-3: Observed Wave Height at CDIP144 vs. Wavewatch Forecast at 27.00°N, 84.00°W (Time Zone = GMT).

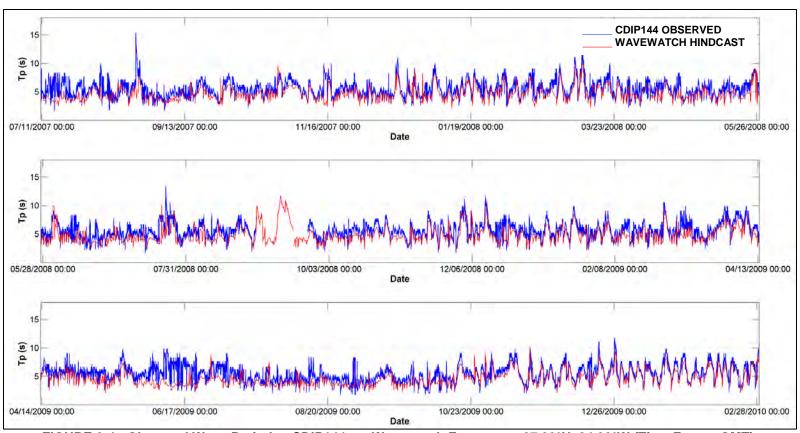
FIGURE 2-4: Observed Wave Period at CDIP144 vs. Wavewatch Forecast at 27.00°N, 84.00°W (Time Zone = GMT).

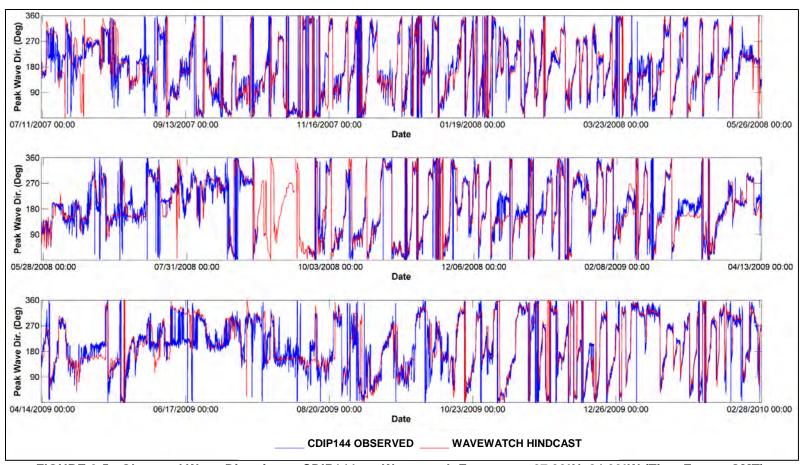
FIGURE 2-5: Observed Wave Direction at CDIP144 vs. Wavewatch Forecast at 27.00°N, 84.00°W (Time Zone = GMT).

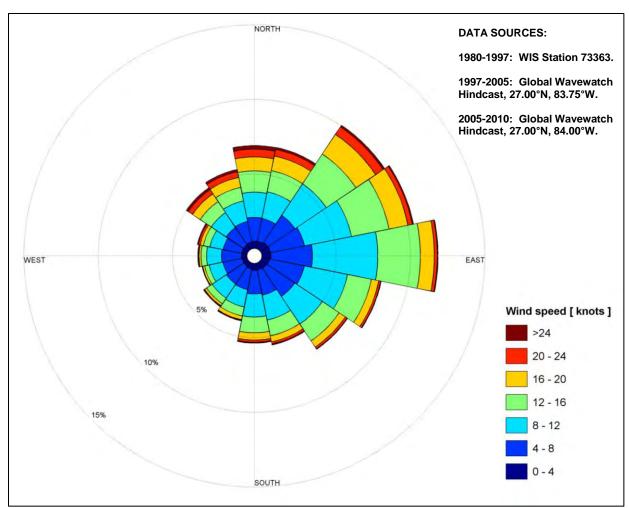
FIGURE 2-6: January 1980 – February 2010 Wind Rose.

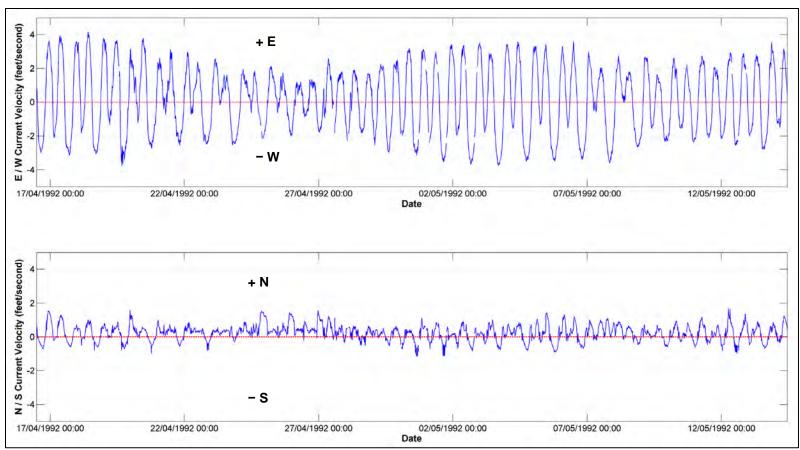
FIGURE 2-10: ATM (1993) Observed Currents in Longboat Pass (Time Zone = EDT).

Water levels and currents were measured by ATM (1993) to support its 1993 inlet management study for Longboat Pass. The locations of these measurements appear in Table 2-3 and Figure 2-7. Water levels were tabulated in feet NGVD every 20 minutes relative to Eastern Daylight Time (EDT); the data was subsequently converted to NAVD assuming NGVD = -0.99 feet NAVD (Figures 2-8 to 2-9). Currents were tabulated in feet/second every 10 minutes relative to EDT (Figure 2-10). The offshore water levels were comparable to the predicted tides at Clearwater Beach. The differences between the two were similar to the residual tide at the St. Petersburg tide gage (NOAA, 2010). Water levels at the Bayside Tide Gage appeared to be 1 foot lower than those at the Offshore Tide Gage. Although their variation appeared to be correct, there may have been an error regarding the referencing of the water levels to NGVD. At the 1992 Current Gage, peak flood and ebb currents were on the order 1.2 to 4.2 feet/second, with a principal current axis of 83°/ 263°.

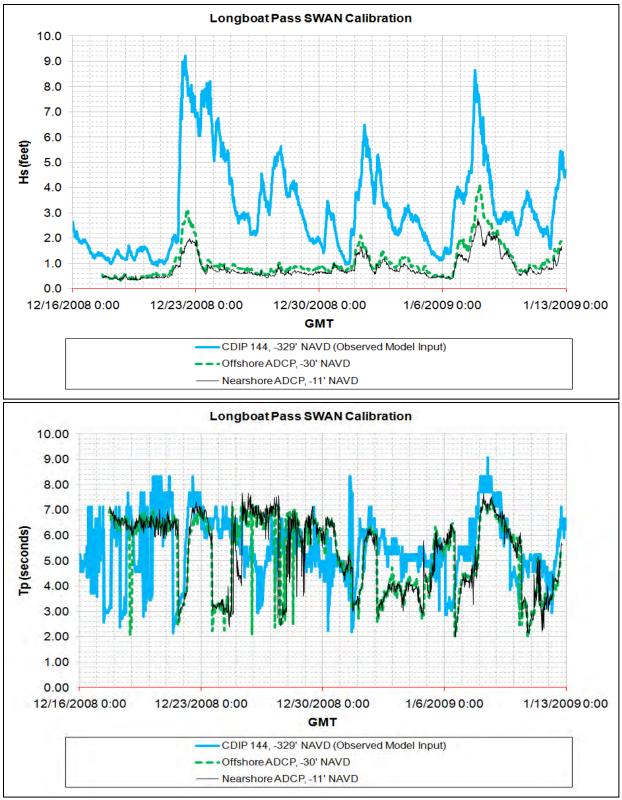
FIGURE 3-6: Observed Waves during the Calibration Period.

Calibration of the SWAN model was based on wave measurements at the Nearshore and Offshore ADCPs between December 17, 2008 and January 12, 2009. The offshore boundary condition on the Regional Wave Grid was based on observed waves at Wave Gage CDIP144 (Figures 3-6 to 3-8). Input to the model was specified using 9 band wave spectra provided by Scripps Institute of Oceanography (SIO, 2009) (see Figure 3-8). Wind velocities were based on wind fields provided as part of the Global Wavewatch Forecast. These wind fields were specified over a 0.5° x 0.5° grid at 3 hour intervals. Gaps in the wind fields over land areas were filled using the NOAA (2010) Gaussian Wind Field Grids. A typical input wind field appears in Figure 3-9. Water levels during the calibration period were based on measurements at the Anna Maria Island pier (Figure 3-10) and assumed to be uniform over the model grid.

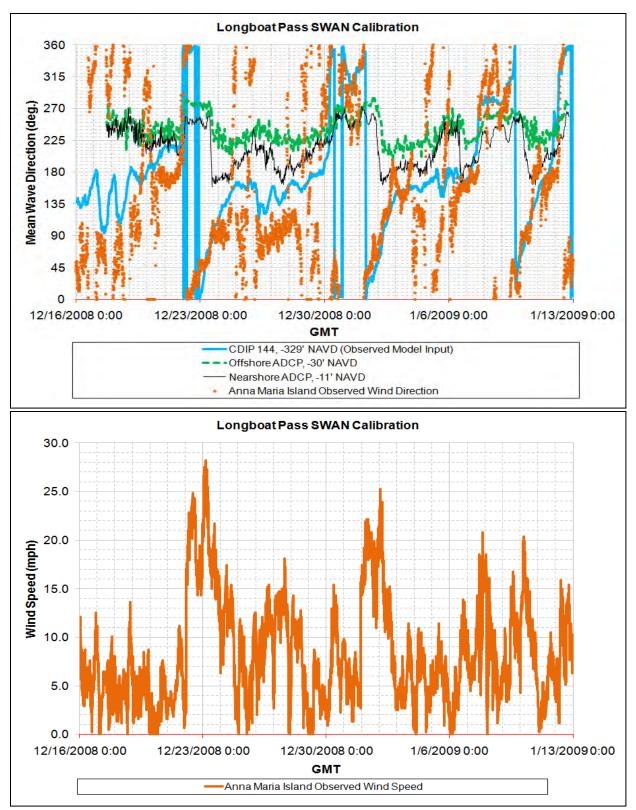
FIGURE 3-7: Observed Waves and Winds during the Calibration Period.

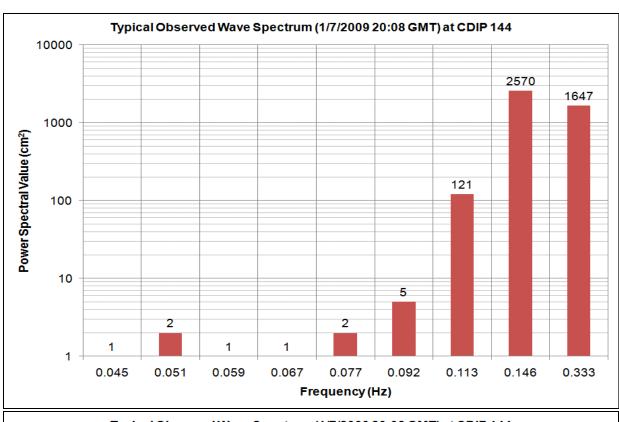
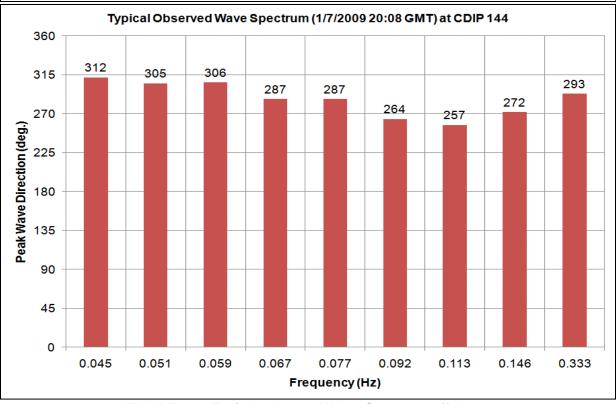
FIGURE 3-8: Typical Observed Wave Spectrum Offshore.

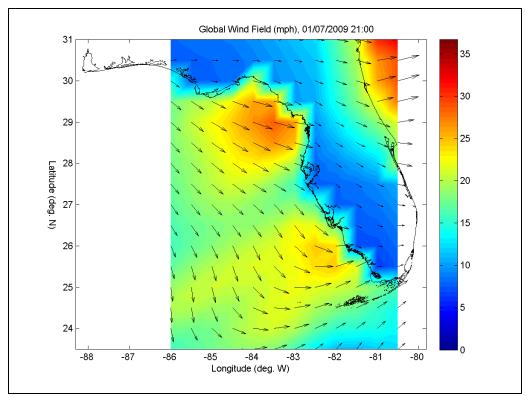
FIGURE 3-9: Typical Wind Field during the Calibration Period (Time Zone = GMT).

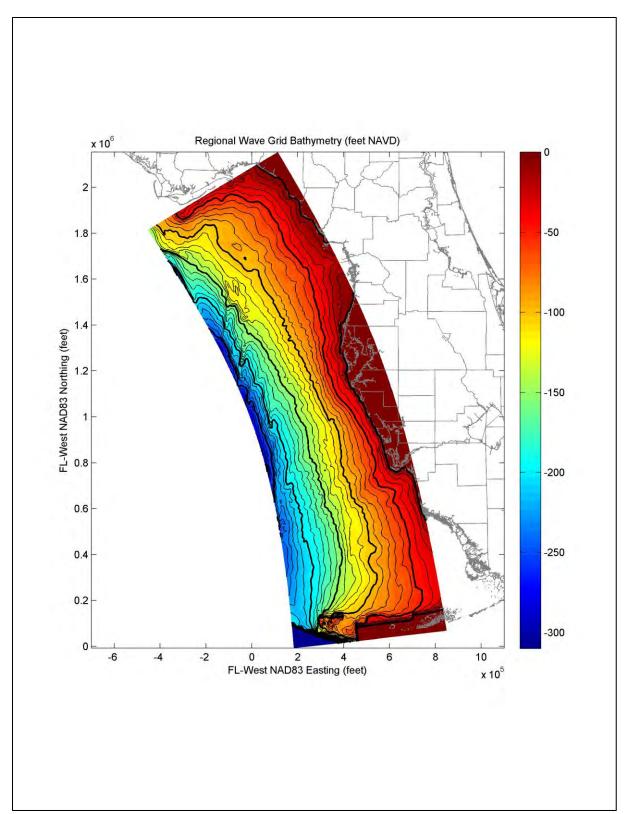
FIGURE 3-11: Bathymetry over the Regional Wave Grid.

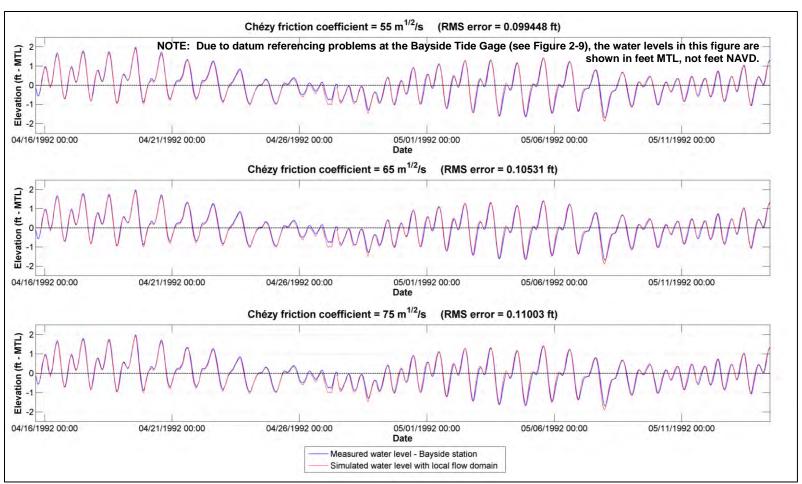
FIGURE 3-29: Simulated vs. Observed Water Levels at the 1992 Bayside Tide Gage (Time Zone = EDT).

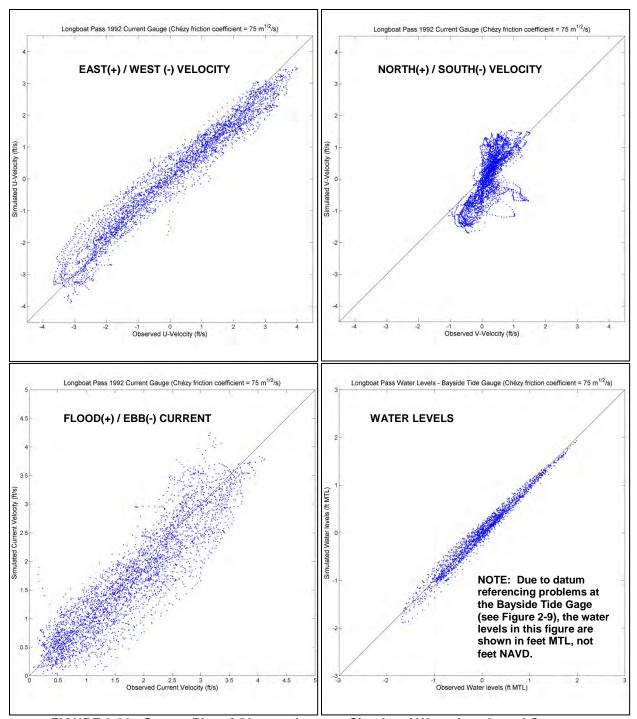
FIGURE 3-30: Scatter Plot of Observed versus Simulated Water Levels and Currents.

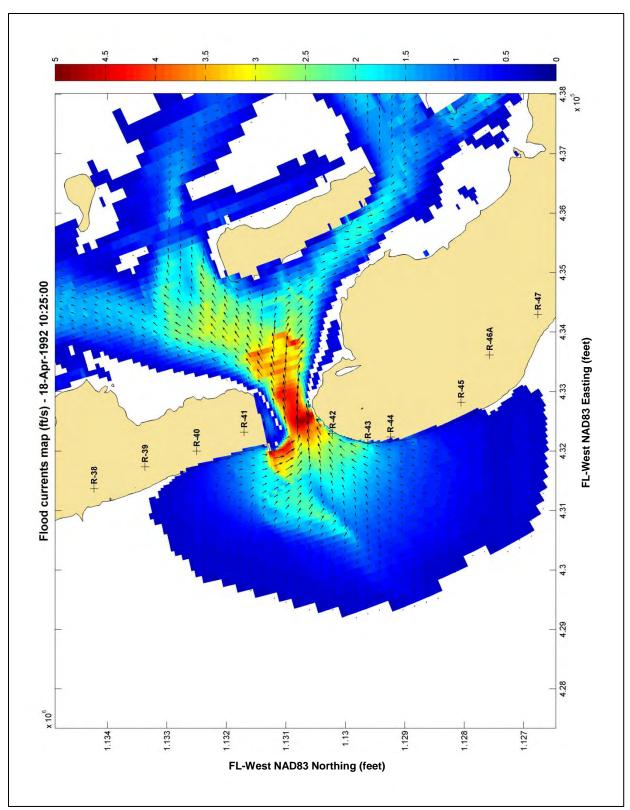
FIGURE 3-31: Typical Peak Flood Flow during the Calibration Period (Time Zone = EDT).

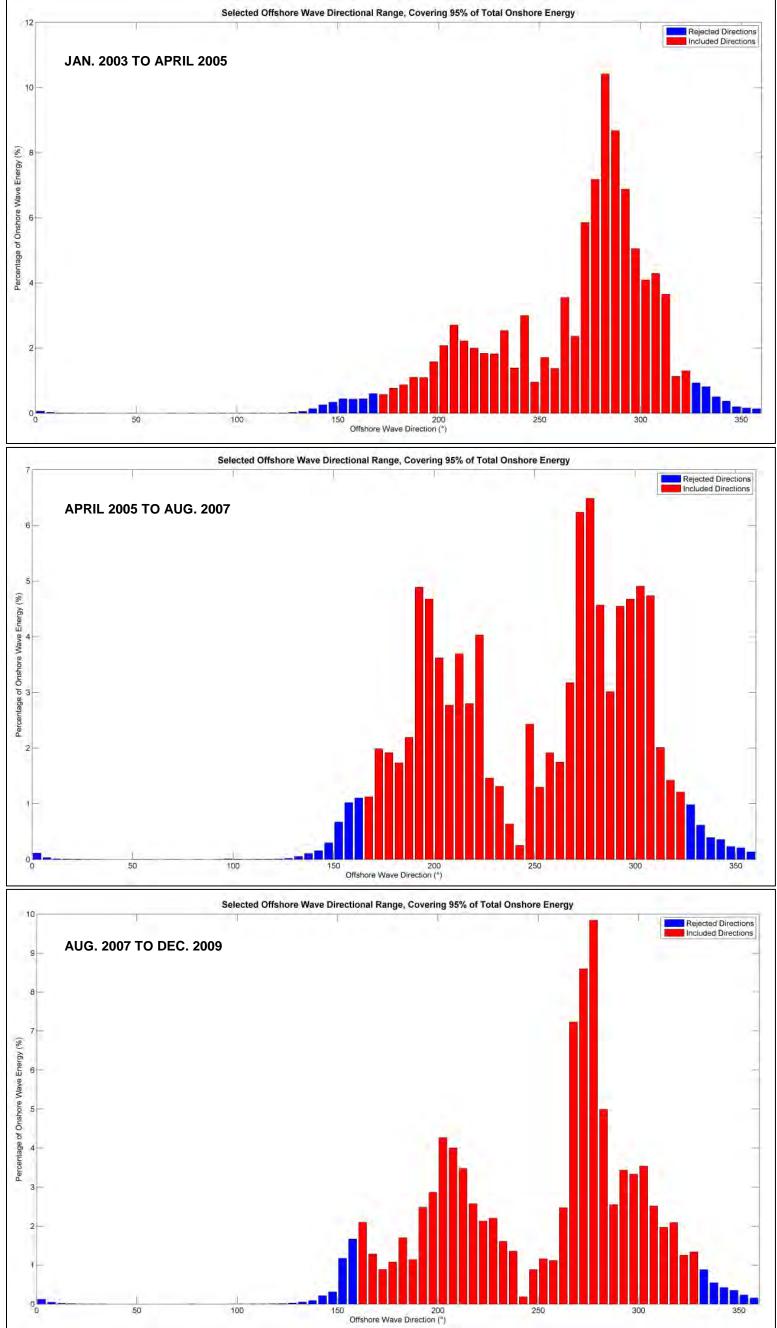
FIGURE 3-37: Selected Offshore Directional Ranges that Cover 95% of Total Onshore Energy.

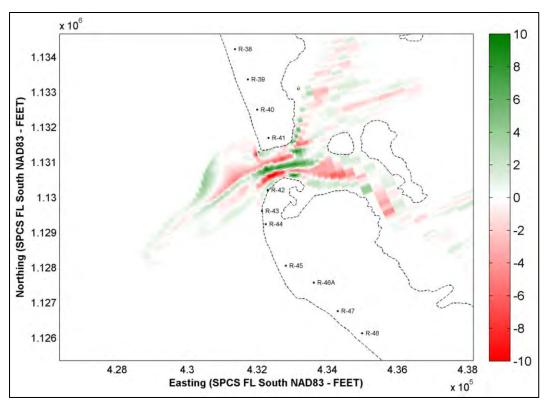
FIGURE 3-38: Six Month Erosion (-feet) and Deposition (+feet) Given the Observed Tides in Figure 2-8.

The approach used to identify which tide scheme was appropriate consisted of simulating six months of morphology changes. The offshore boundary condition for this model run was the observed water level in Figure 2-8. The initial condition was the bathymetry in Figure 3-33. To simulate 6 months of changes using the 1 month record length, a morphological acceleration factor of 6 was used. Similar simulations were conducted using the schematized tides in Table 3-6. In order to focus on tidal effects only, waves were not included in these 4 simulations and default sediment transport parameters were used. The morphological responses of Tide Schemes 1-3 (Table 3-6) were then compared with those of the observed tides in Figure 2-8. The results appear in Figures 3-38 to 3-41.

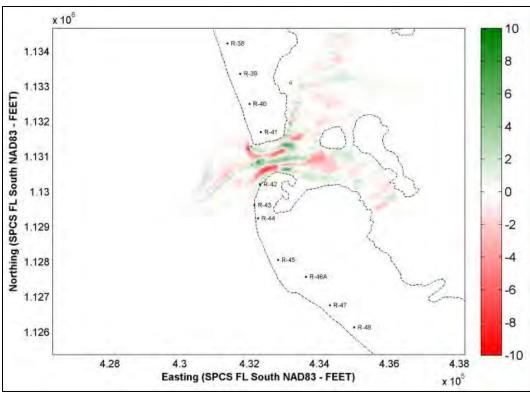
FIGURE 3-39: Six Month Erosion (-feet) and Deposition (+feet) Given Tide Scheme #1 in Table 3-6.

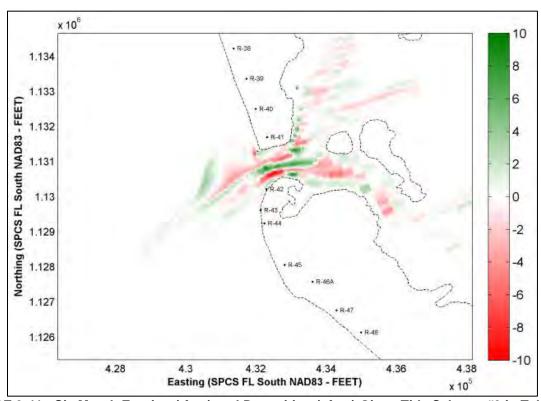
FIGURE 3-41: Six Month Erosion (-feet) and Deposition (+feet) Given Tide Scheme #3 in Table 3-6.

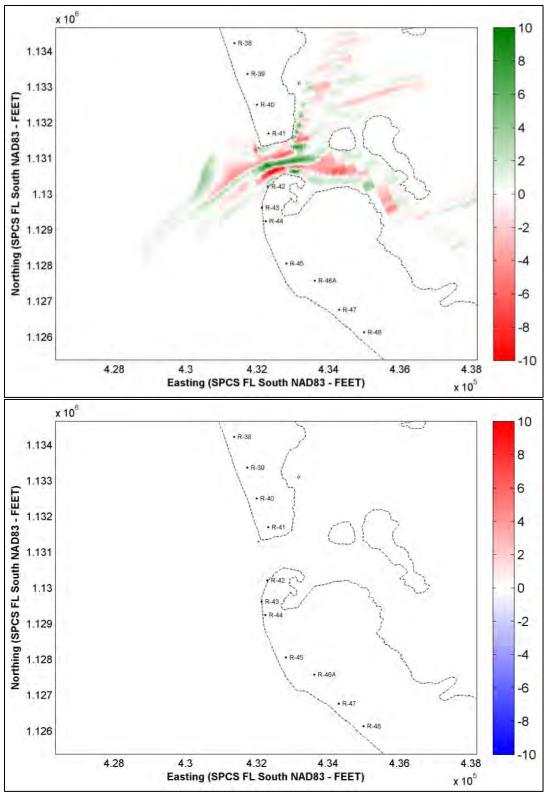
FIGURE 3-43: Six Month Erosion (-feet) and Deposition (+feet) Given the Final Tide Scheme (top), and Differences in Comparison with the Bathymetric Changes in feet Given the Observed Tides (bottom).

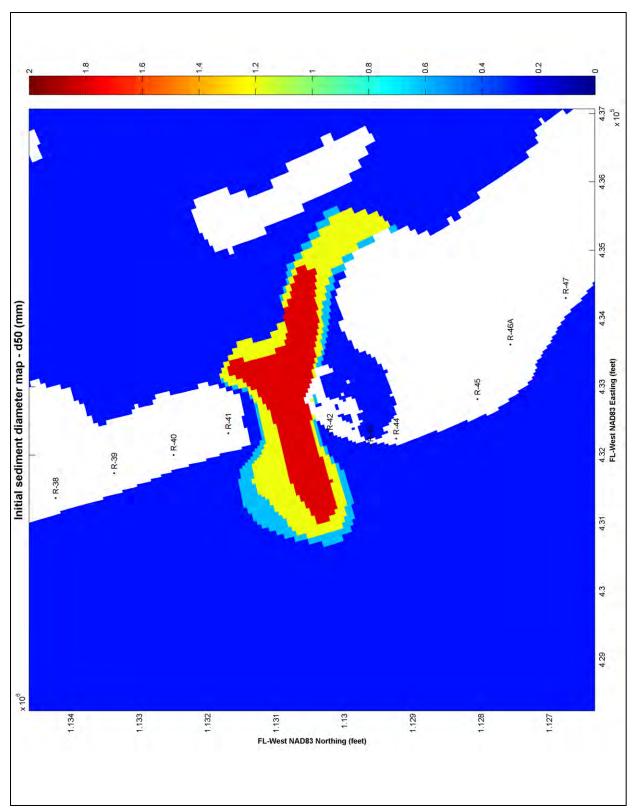
FIGURE 3-44: Grain Size Distribution at the Beginning of the Final Calibration Run.

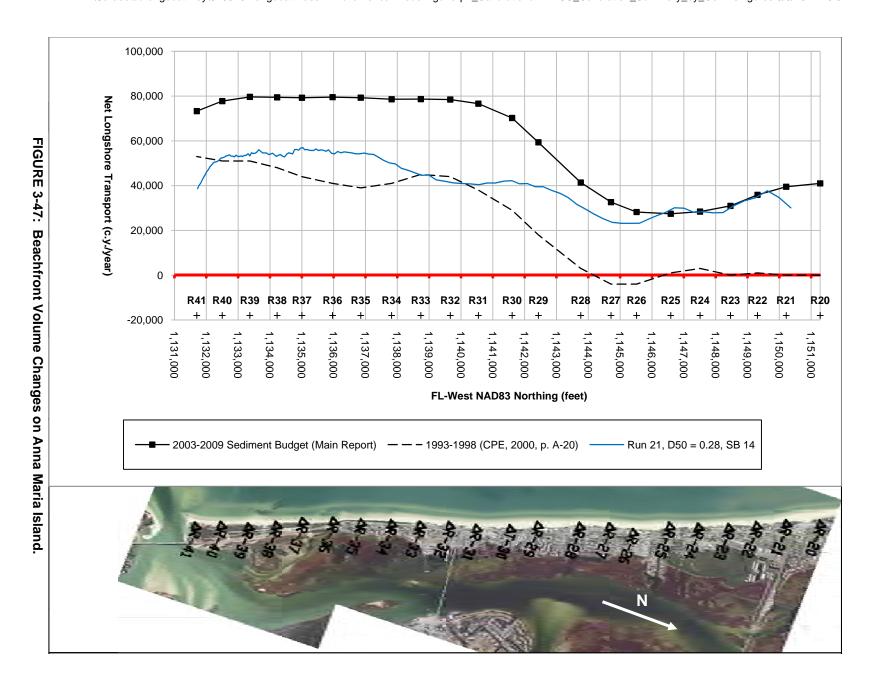
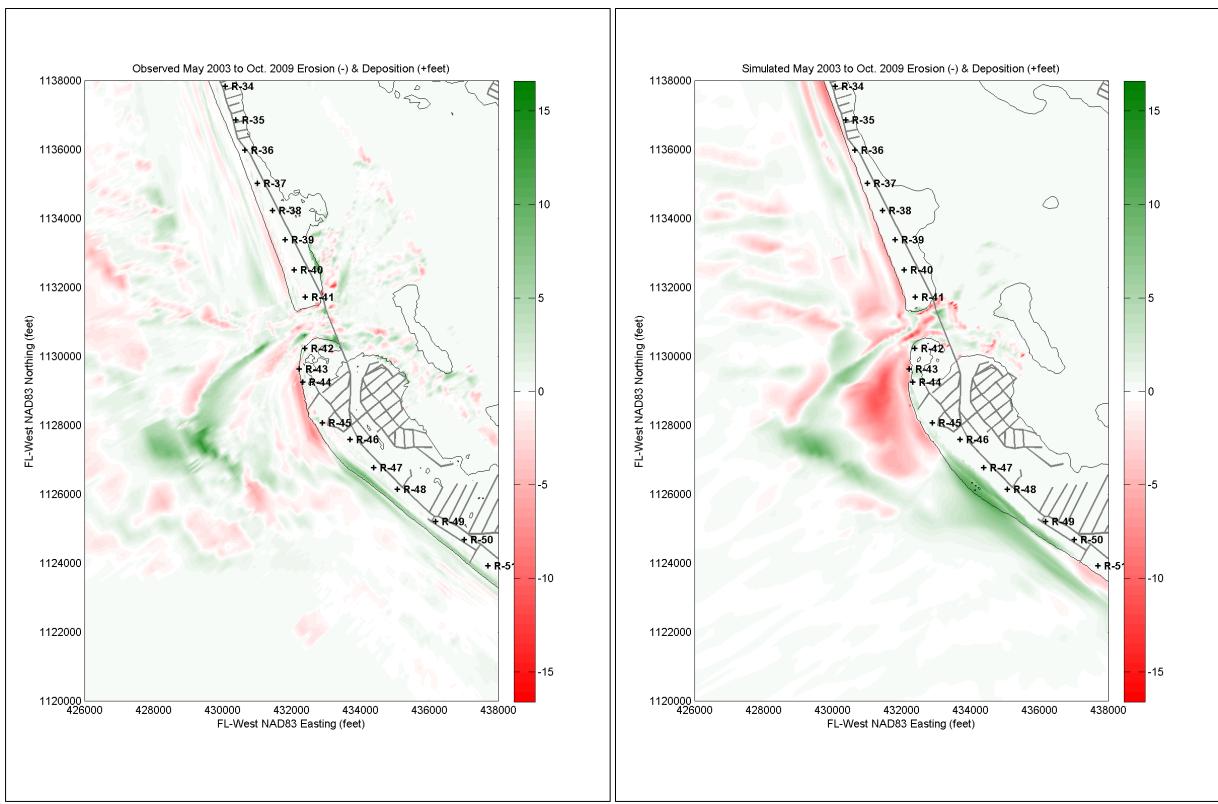
FIGURE 3-48: Comparison of Observed and Simulated Erosion and Deposition Patterns between 2003 and 2009.

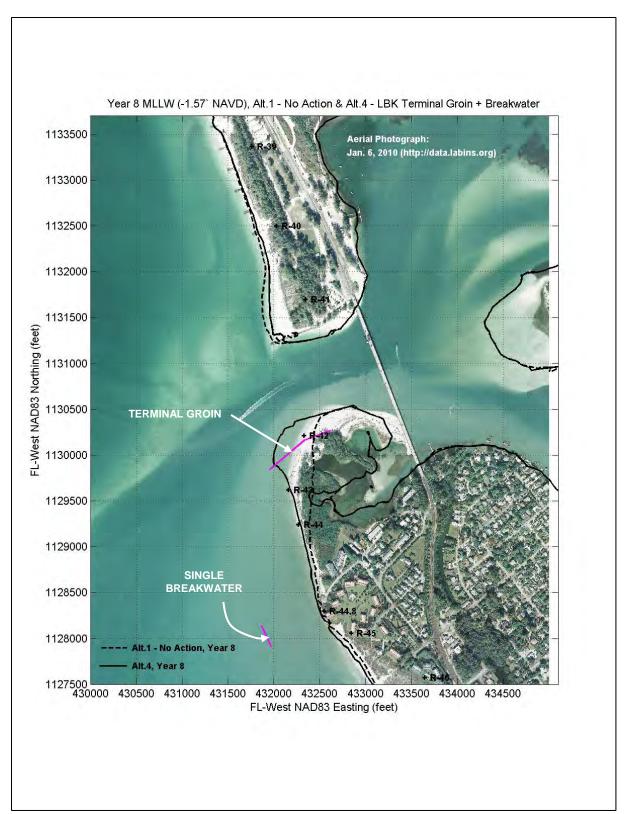
FIGURE 4-13: Simulated MLLW Positions Given Alternatives 1 and 4.

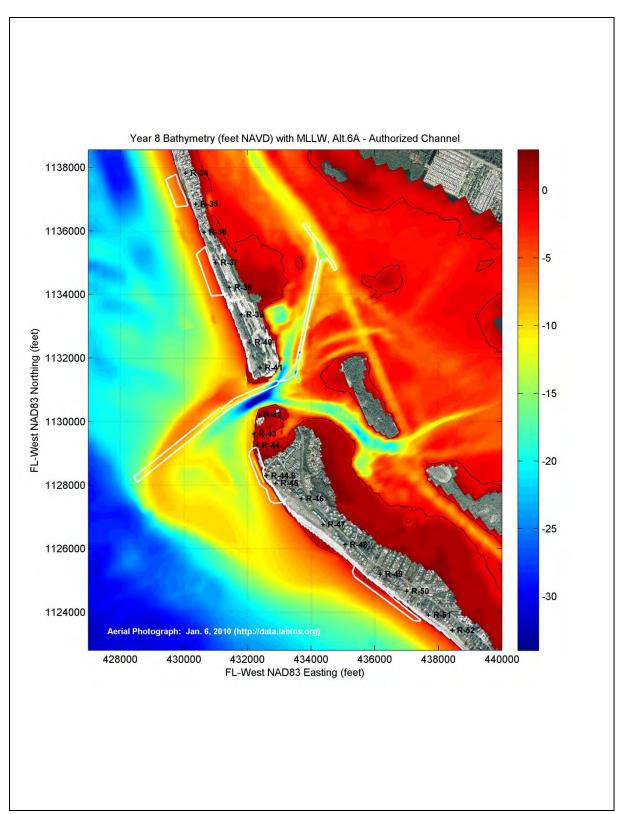
FIGURE 4-21: Simulated Bathymetry at Year 8 Given Alternative 6A.

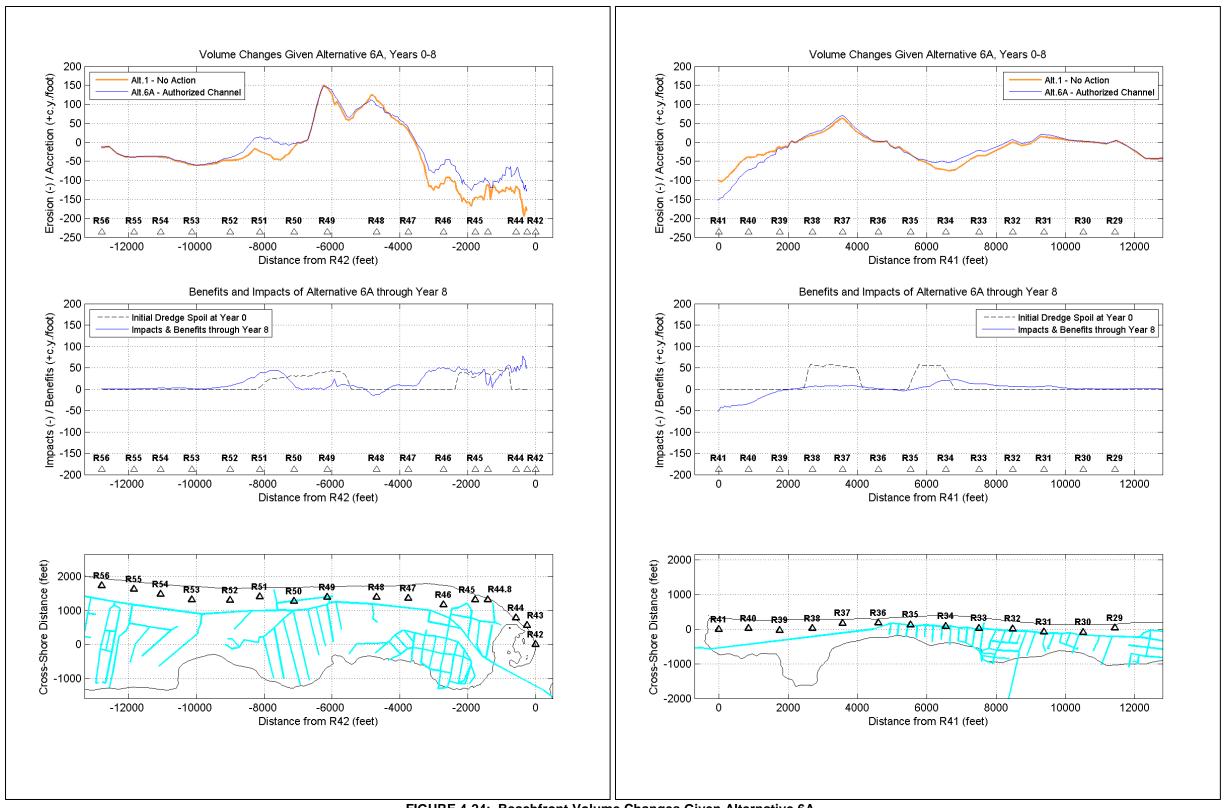
FIGURE 4-24: Beachfront Volume Changes Given Alternative 6A.
