MANATEE COUNTY & THE TOWN OF LONGBOAT KEY

COASTAL PLANNING & ENGINEERING, INC.

OCTOBER 2011

Executive Summary

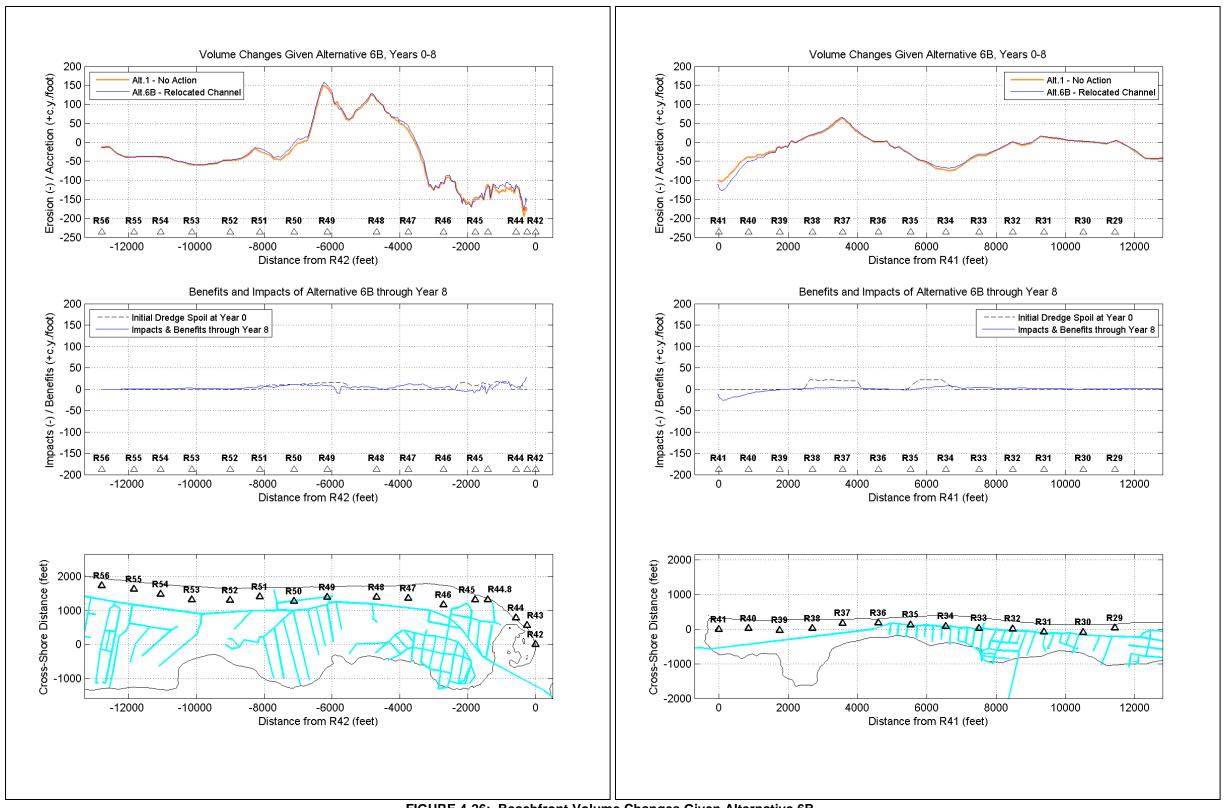
FIGURE 4-26: Beachfront Volume Changes Given Alternative 6B.

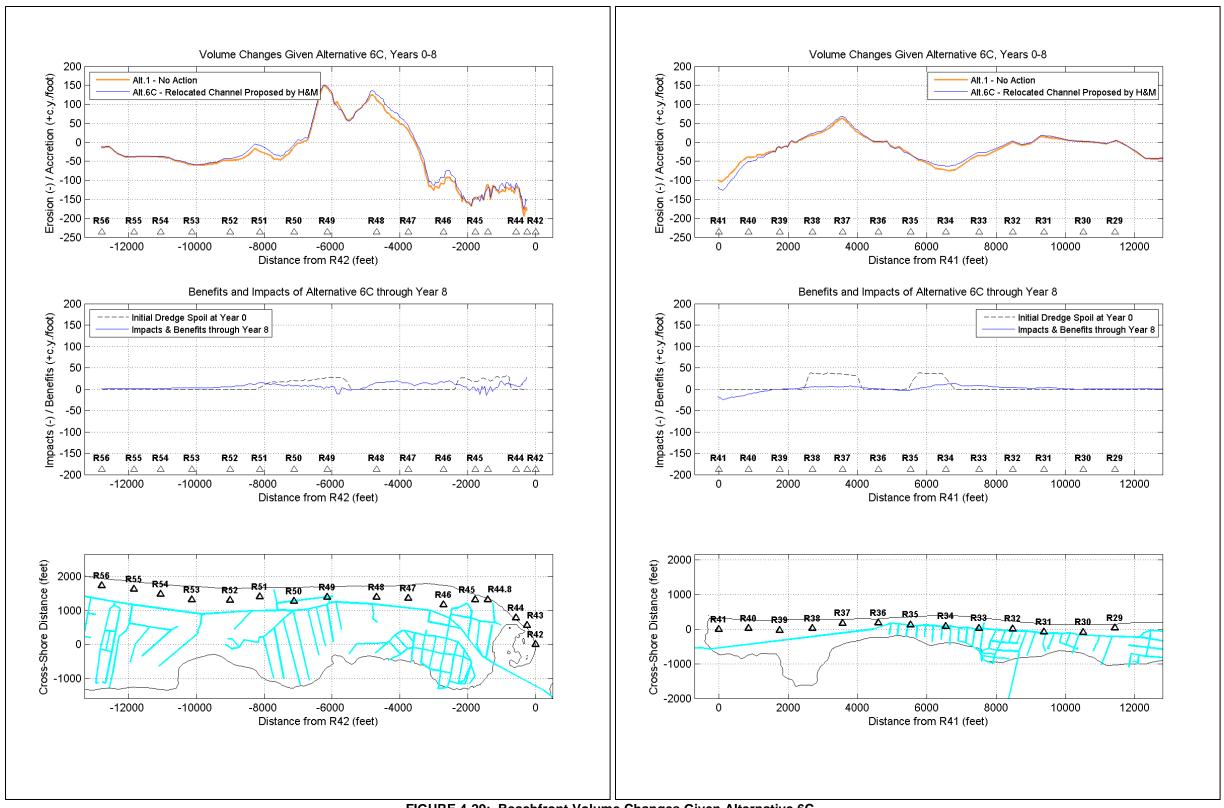
FIGURE 4-29: Beachfront Volume Changes Given Alternative 6C.

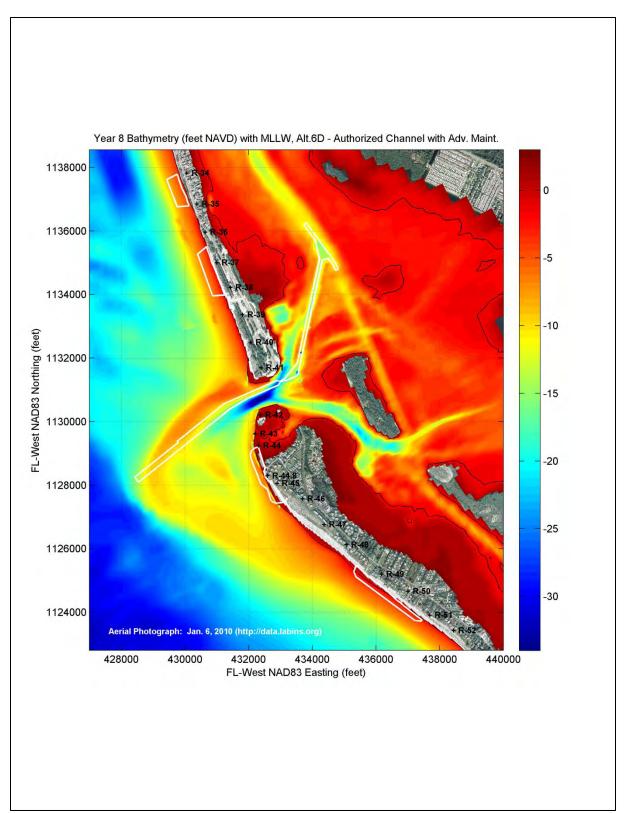
FIGURE 4-31: Simulated Bathymetry at Year 8 Given Alternative 6D.

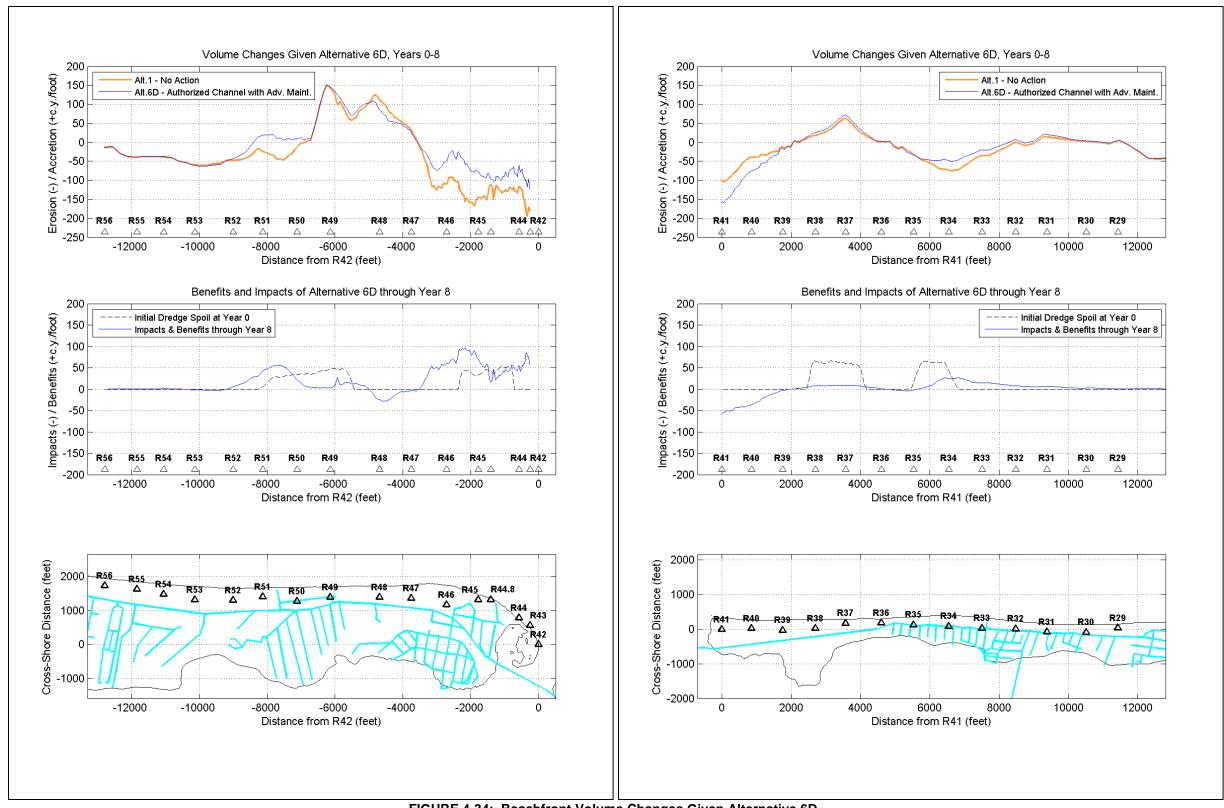
FIGURE 4-34: Beachfront Volume Changes Given Alternative 6D.

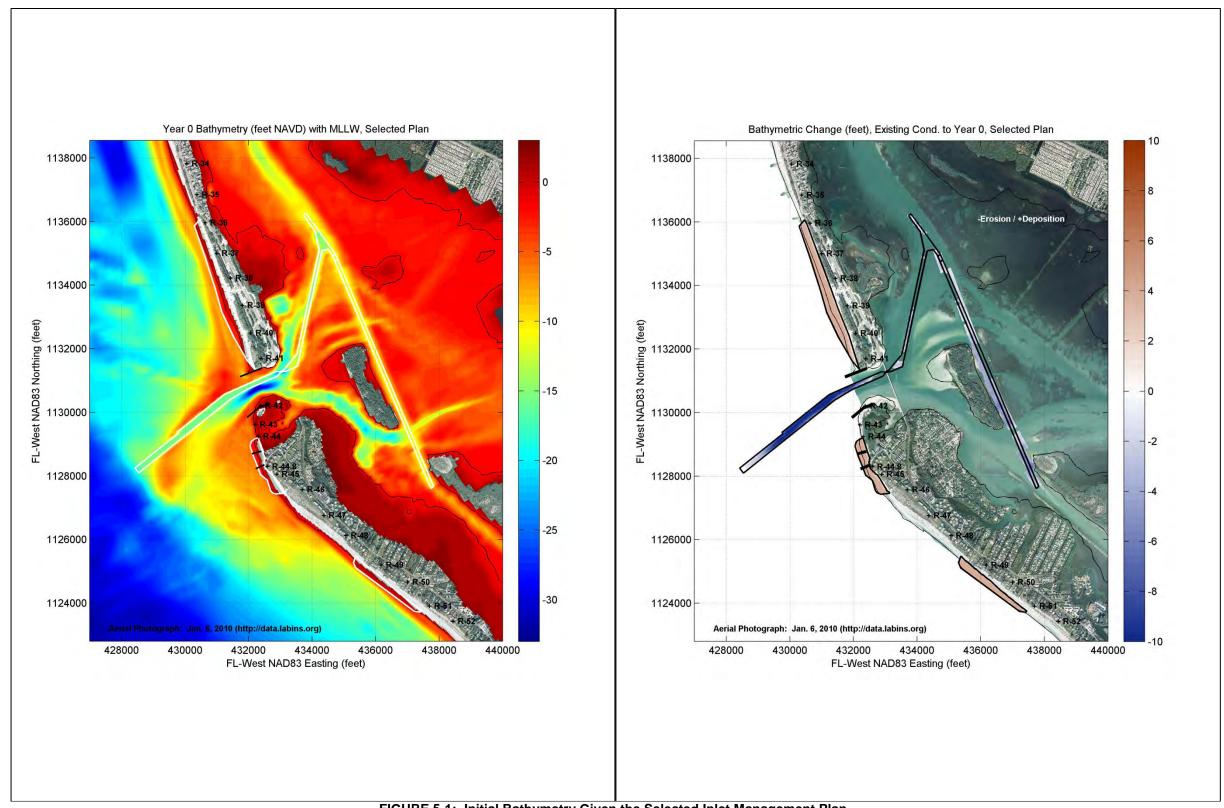
FIGURE 5-1: Initial Bathymetry Given the Selected Inlet Management Plan.

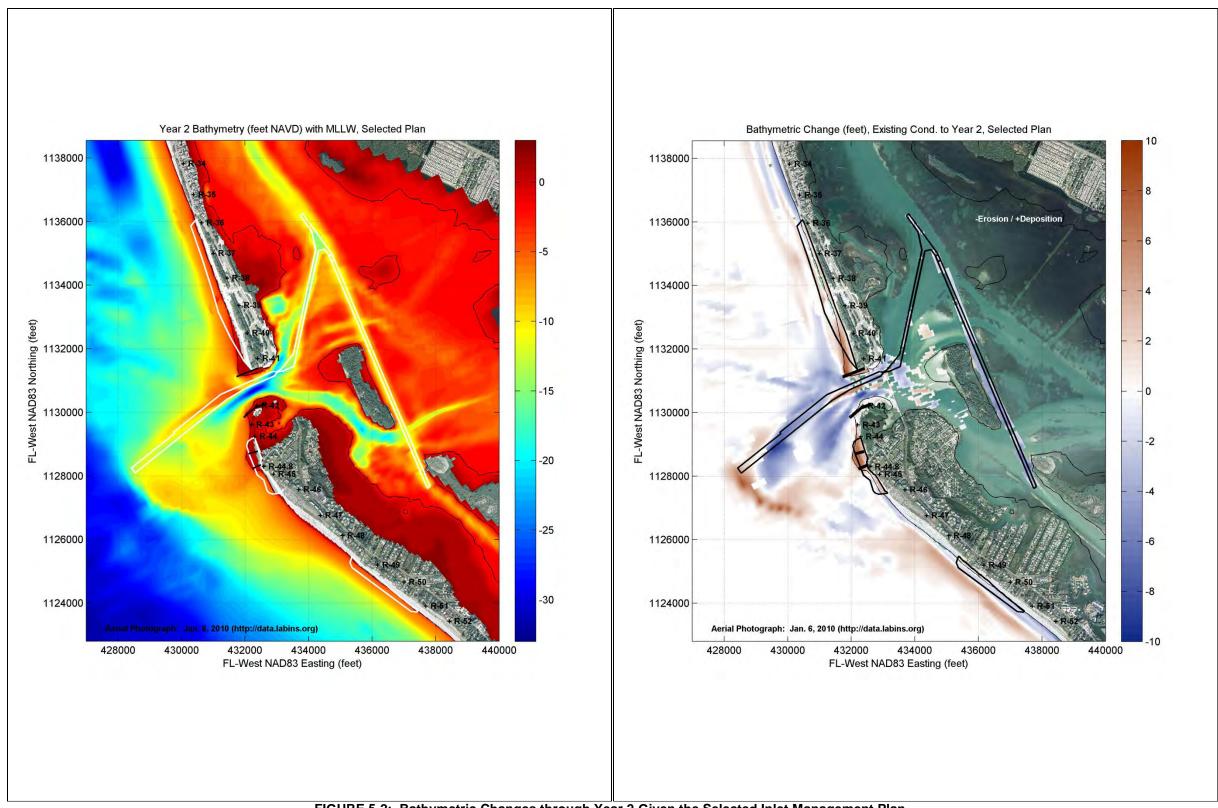
FIGURE 5-2: Bathymetric Changes through Year 2 Given the Selected Inlet Management Plan.

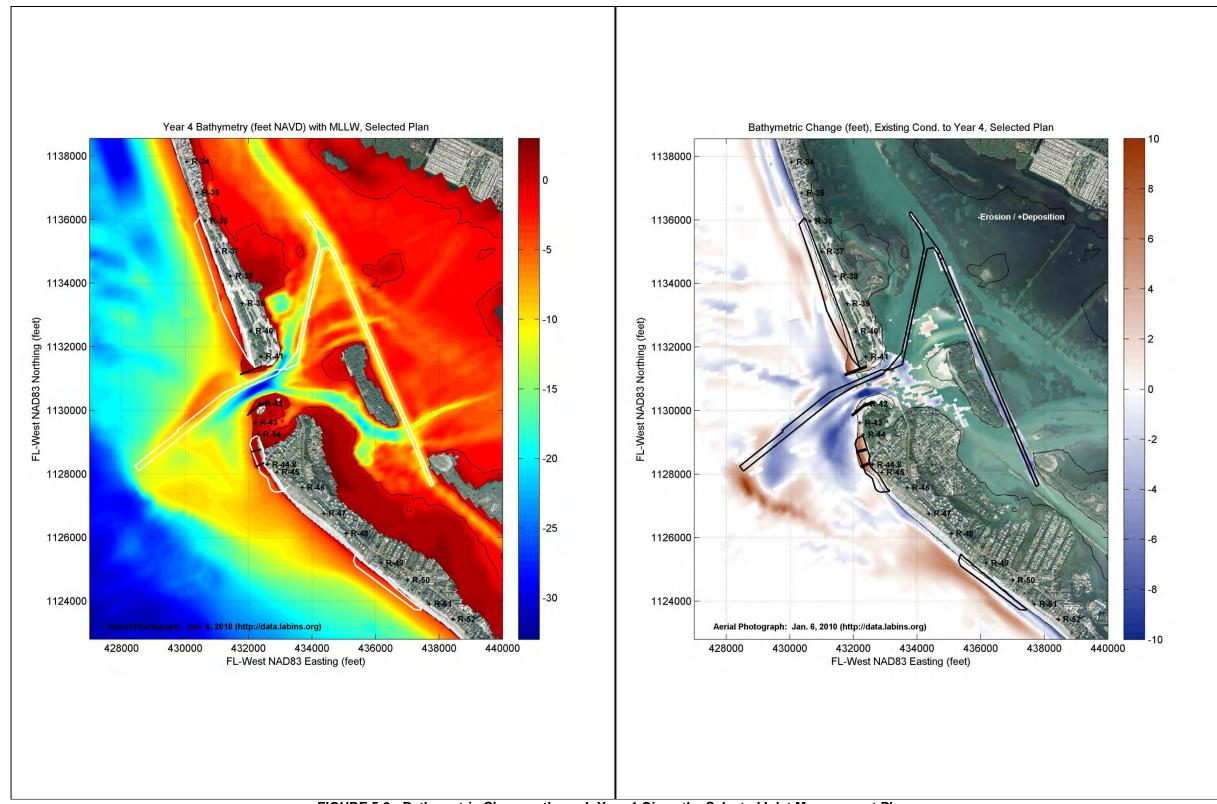
FIGURE 5-3: Bathymetric Changes through Year 4 Given the Selected Inlet Management Plan.

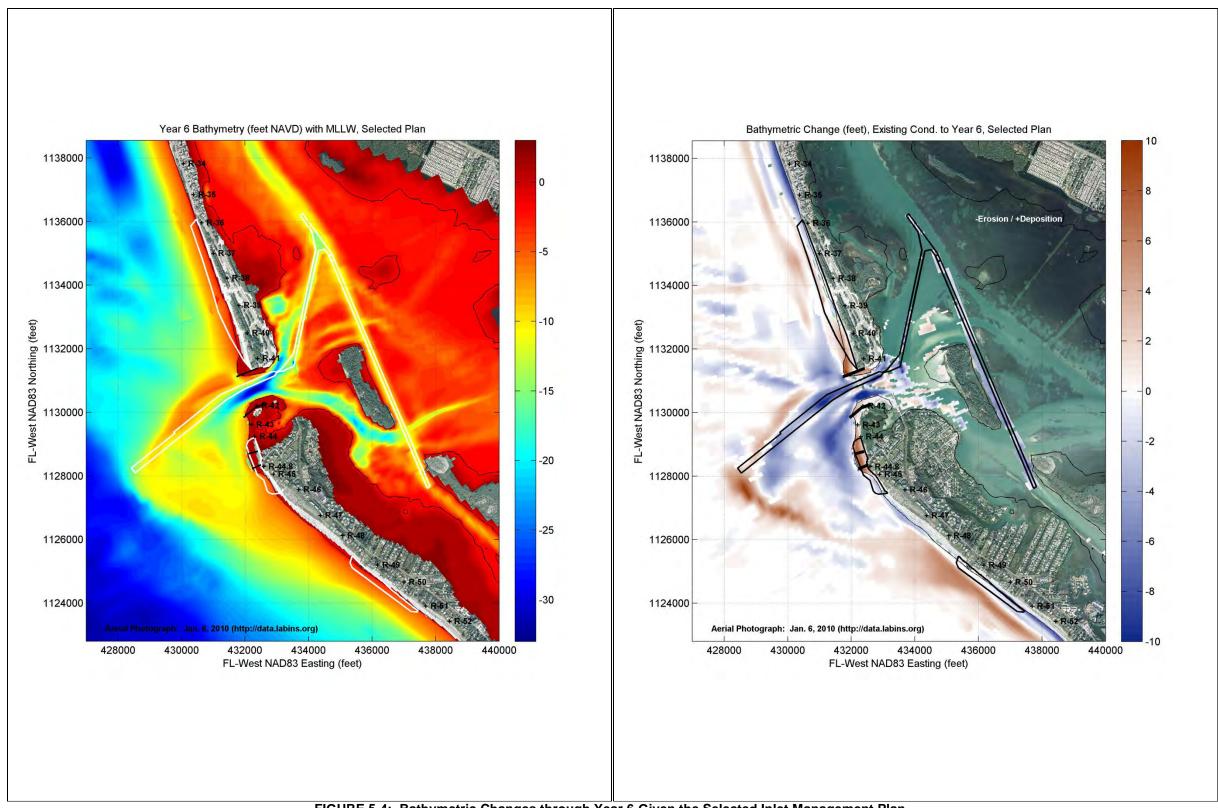
FIGURE 5-4: Bathymetric Changes through Year 6 Given the Selected Inlet Management Plan.

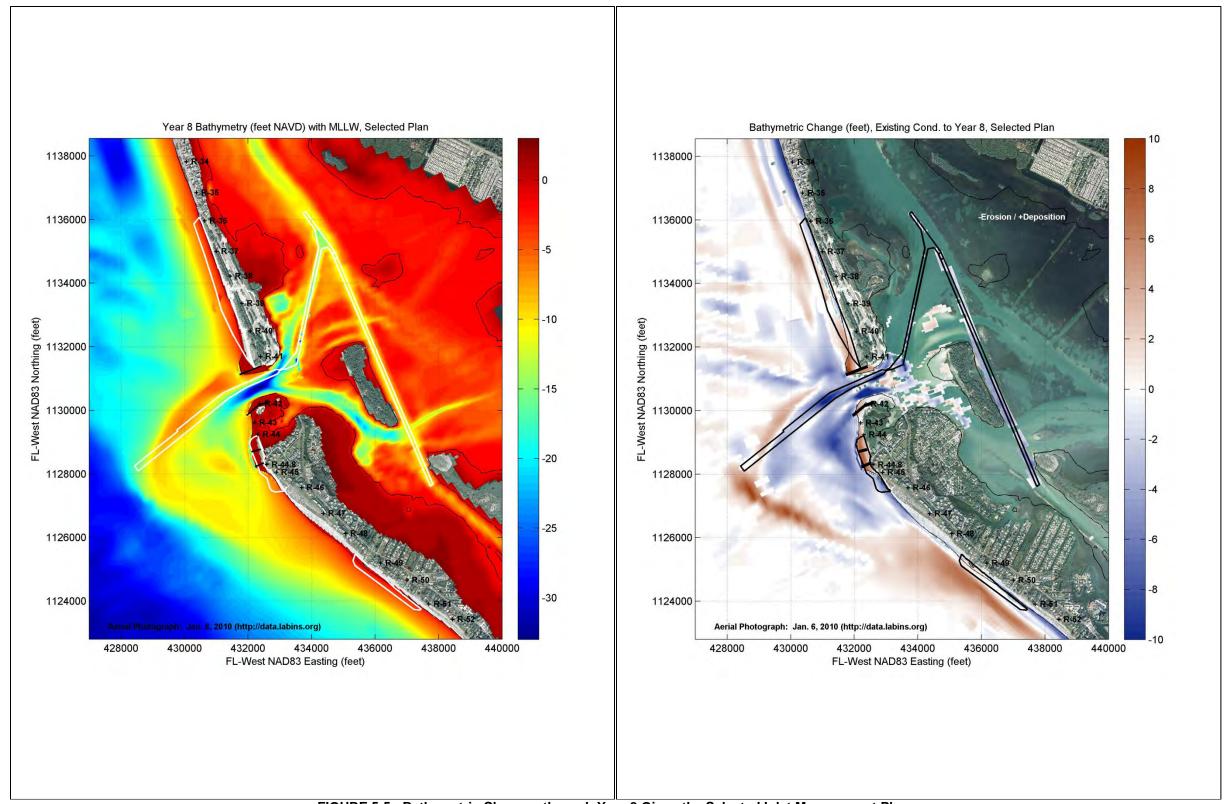
FIGURE 5-5: Bathymetric Changes through Year 8 Given the Selected Inlet Management Plan.

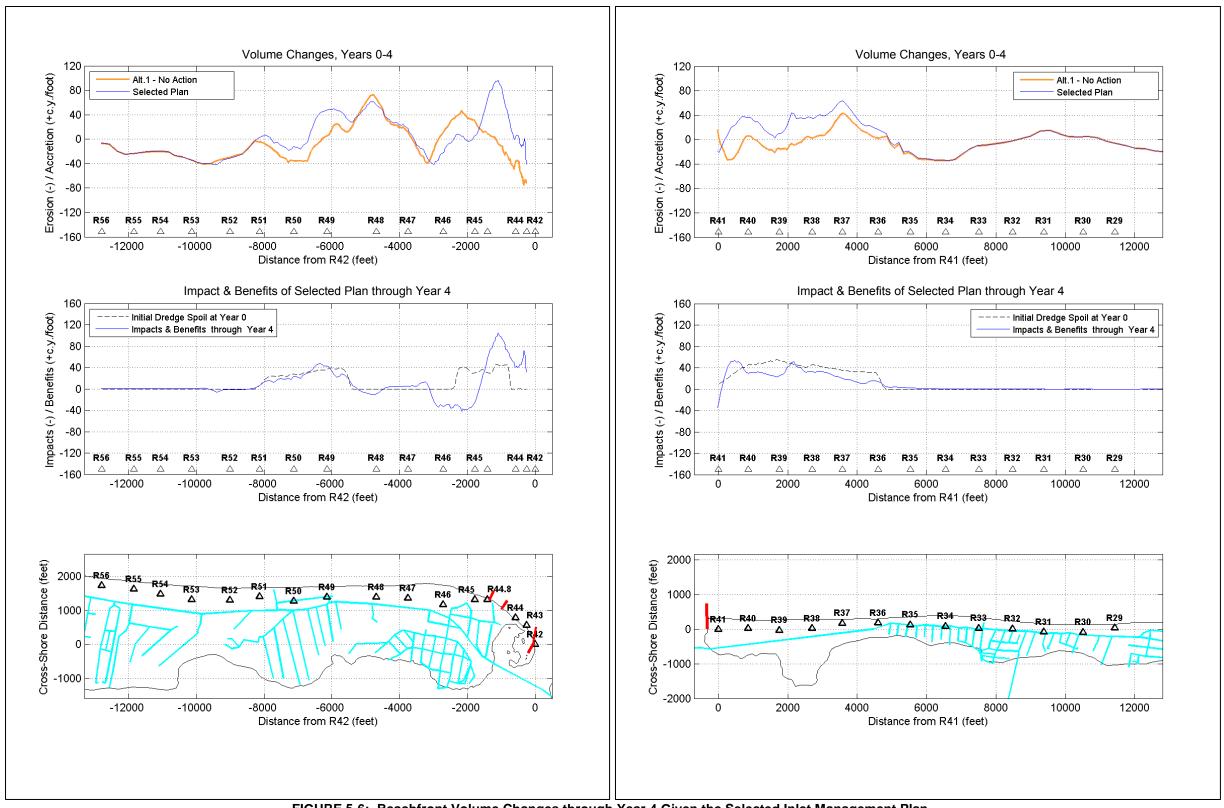
FIGURE 5-6: Beachfront Volume Changes through Year 4 Given the Selected Inlet Management Plan.

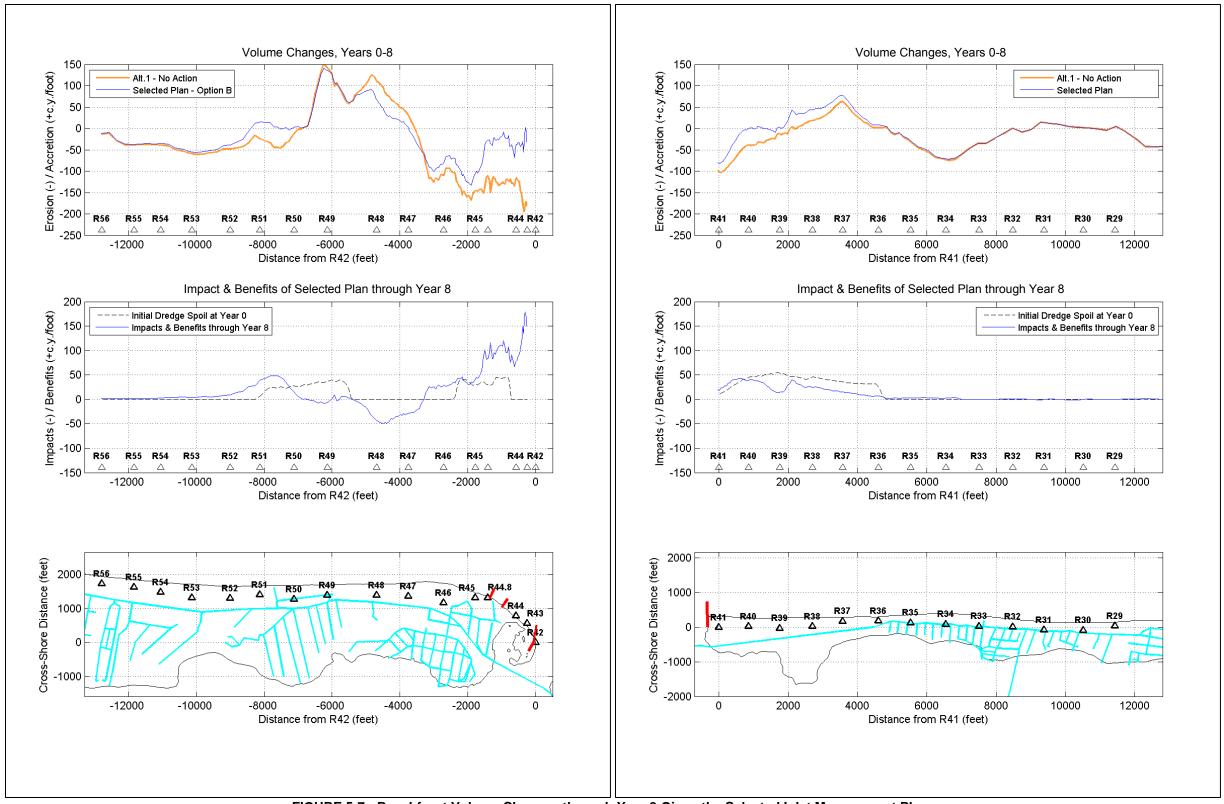
FIGURE 5-7: Beachfront Volume Changes through Year 8 Given the Selected Inlet Management Plan.

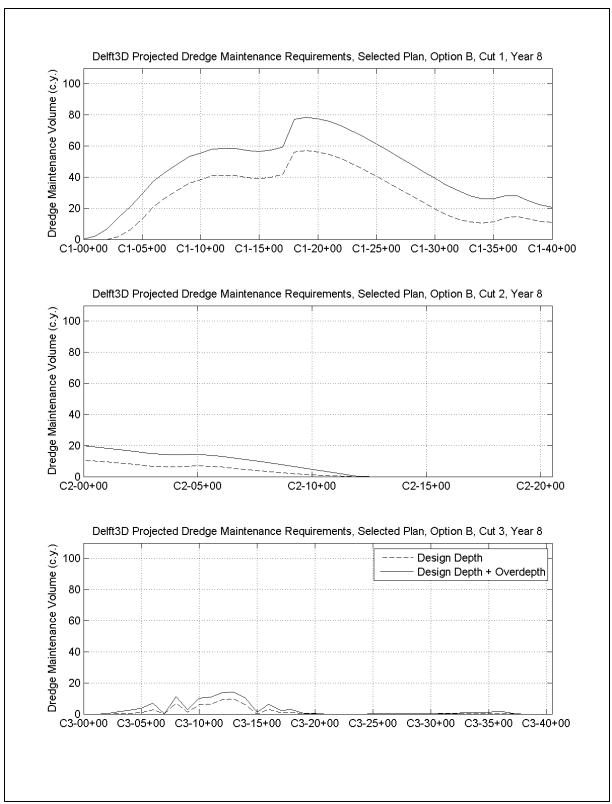
FIGURE 5-15: Projected Dredge Maintenance Requirements at Year 8.

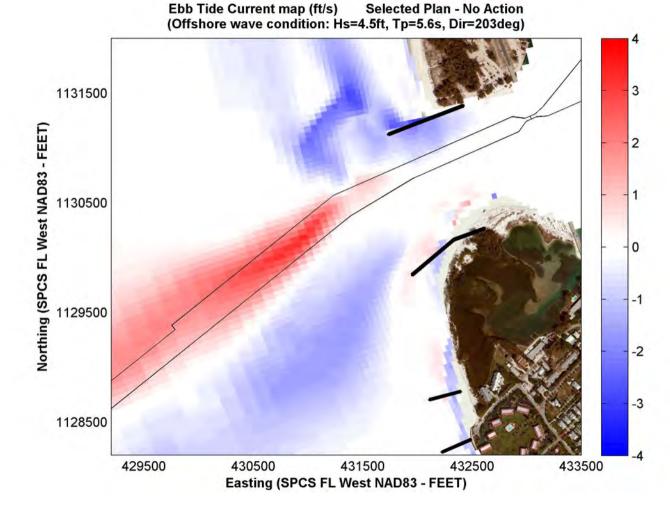
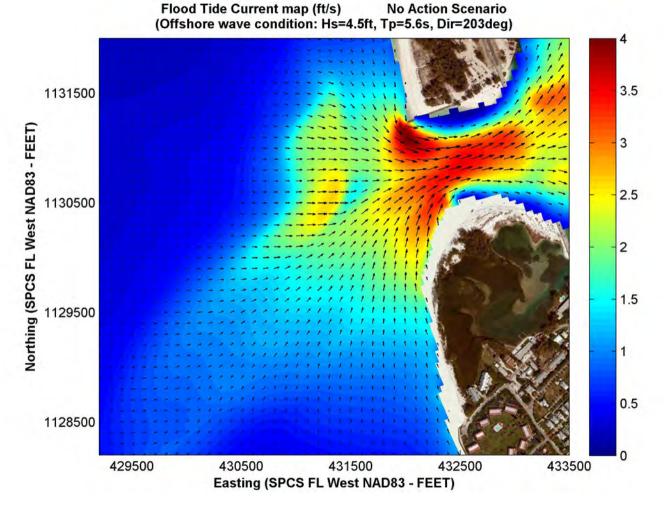
Flood Tide Current map (ft/s) **Selected Plan Scenario** (Offshore wave condition: Hs=4.5ft, Tp=5.6s, Dir=203deg) 3.5 1131500 Northing (SPCS FL West NAD83 - FEET) 3 2.5 1130500 2 1.5 1129500 0.5 1128500 429500 430500 431500 432500 433500 Easting (SPCS FL West NAD83 - FEET)
