Blumberg No. 5137
RSC JC
Warrers Bayou
Photos 1/29/13

Warner's Bayou Boat Ramp

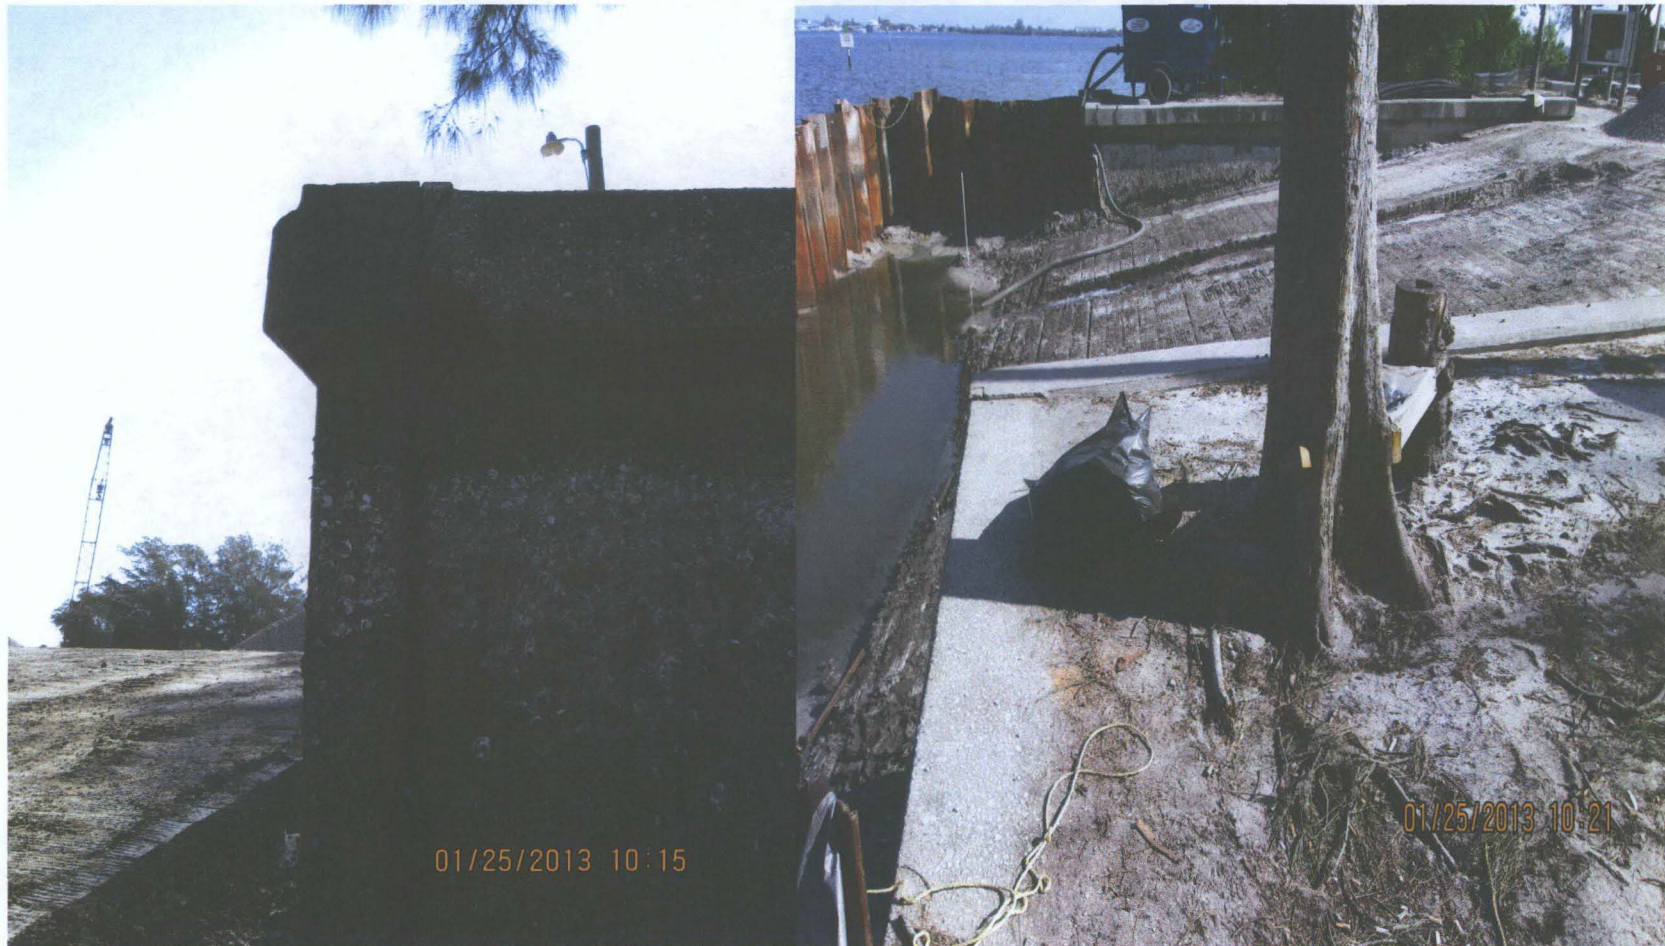
Seawall panel separation, observed after dewatering of the south ramp/dock area. The panels have not moved significantly but auxiliary tie-backs should be installed to preserve their integrity. It is the opinion of the seawall contractor that two large Australian Pines in close proximity to the separation pose a threat to the structural integrity of the wall and must be removed; the trees must also be removed in order to install the tie-backs.
